Appendix 1 – Bioscience Geotech Report

GEOTECHNICAL REPORT

**LOTS 13, 14, 21 & 22
SOUTHERN RIVER ROAD
AND
LOTS 18, 19 & 20
MATISON STREET
SOUTHERN RIVER
MARCH 2010**

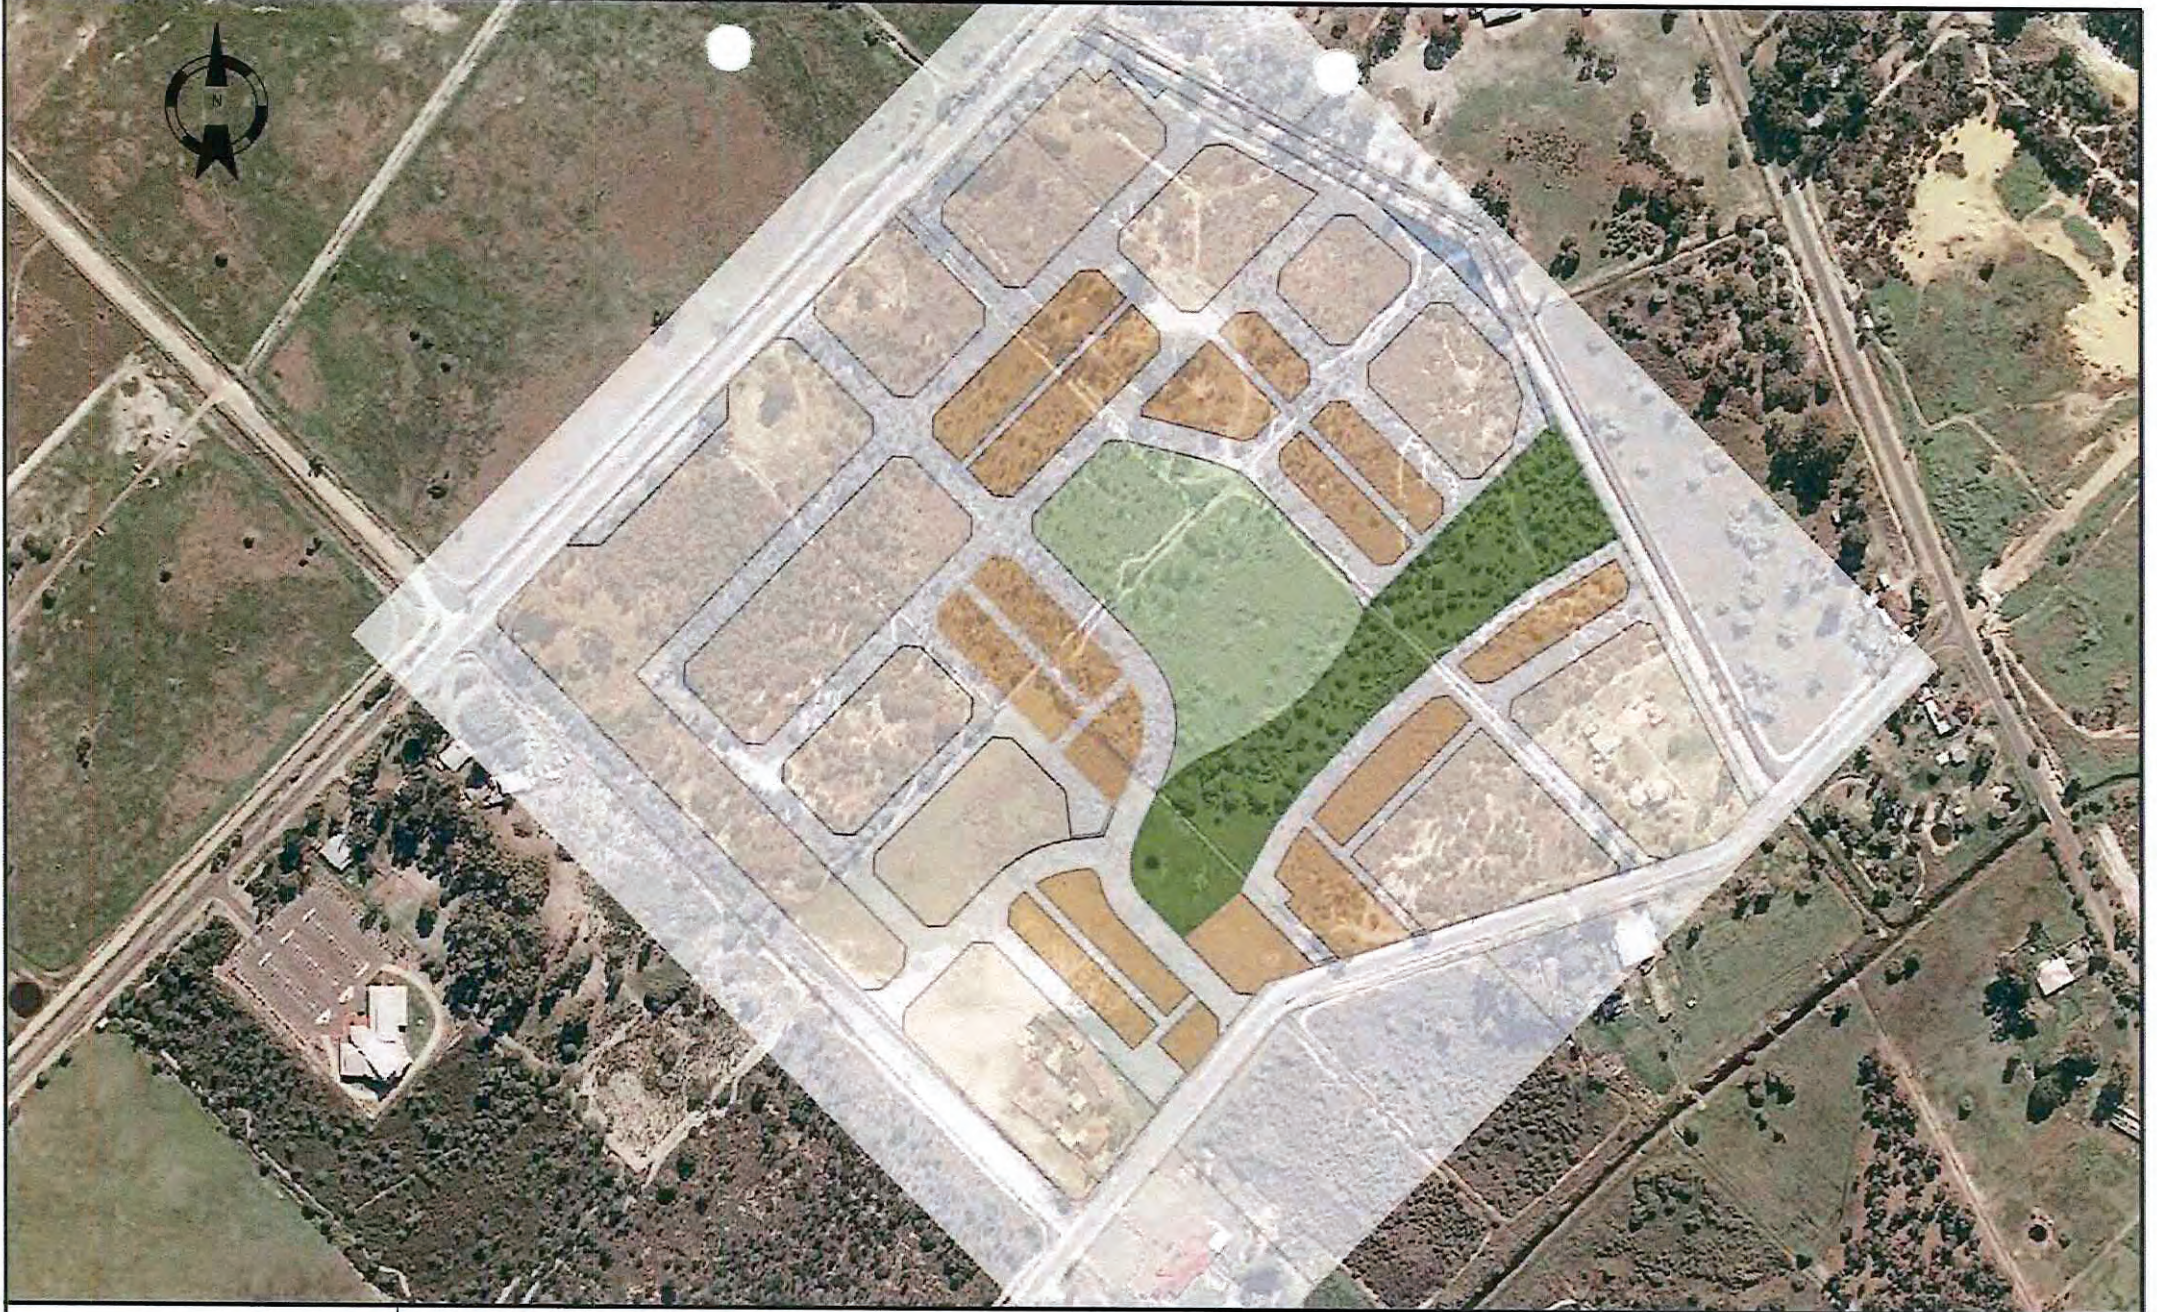
Figure 2 – Outline Development Plan (ODP)

The land is proposed for standard residential development with a base density of R20, with medium density developments of R30 and R40 in areas close to Public Open Space (POS) (Figure 2). Retail, commercial and industrial land uses are not proposed nor are schools or community specific sites.

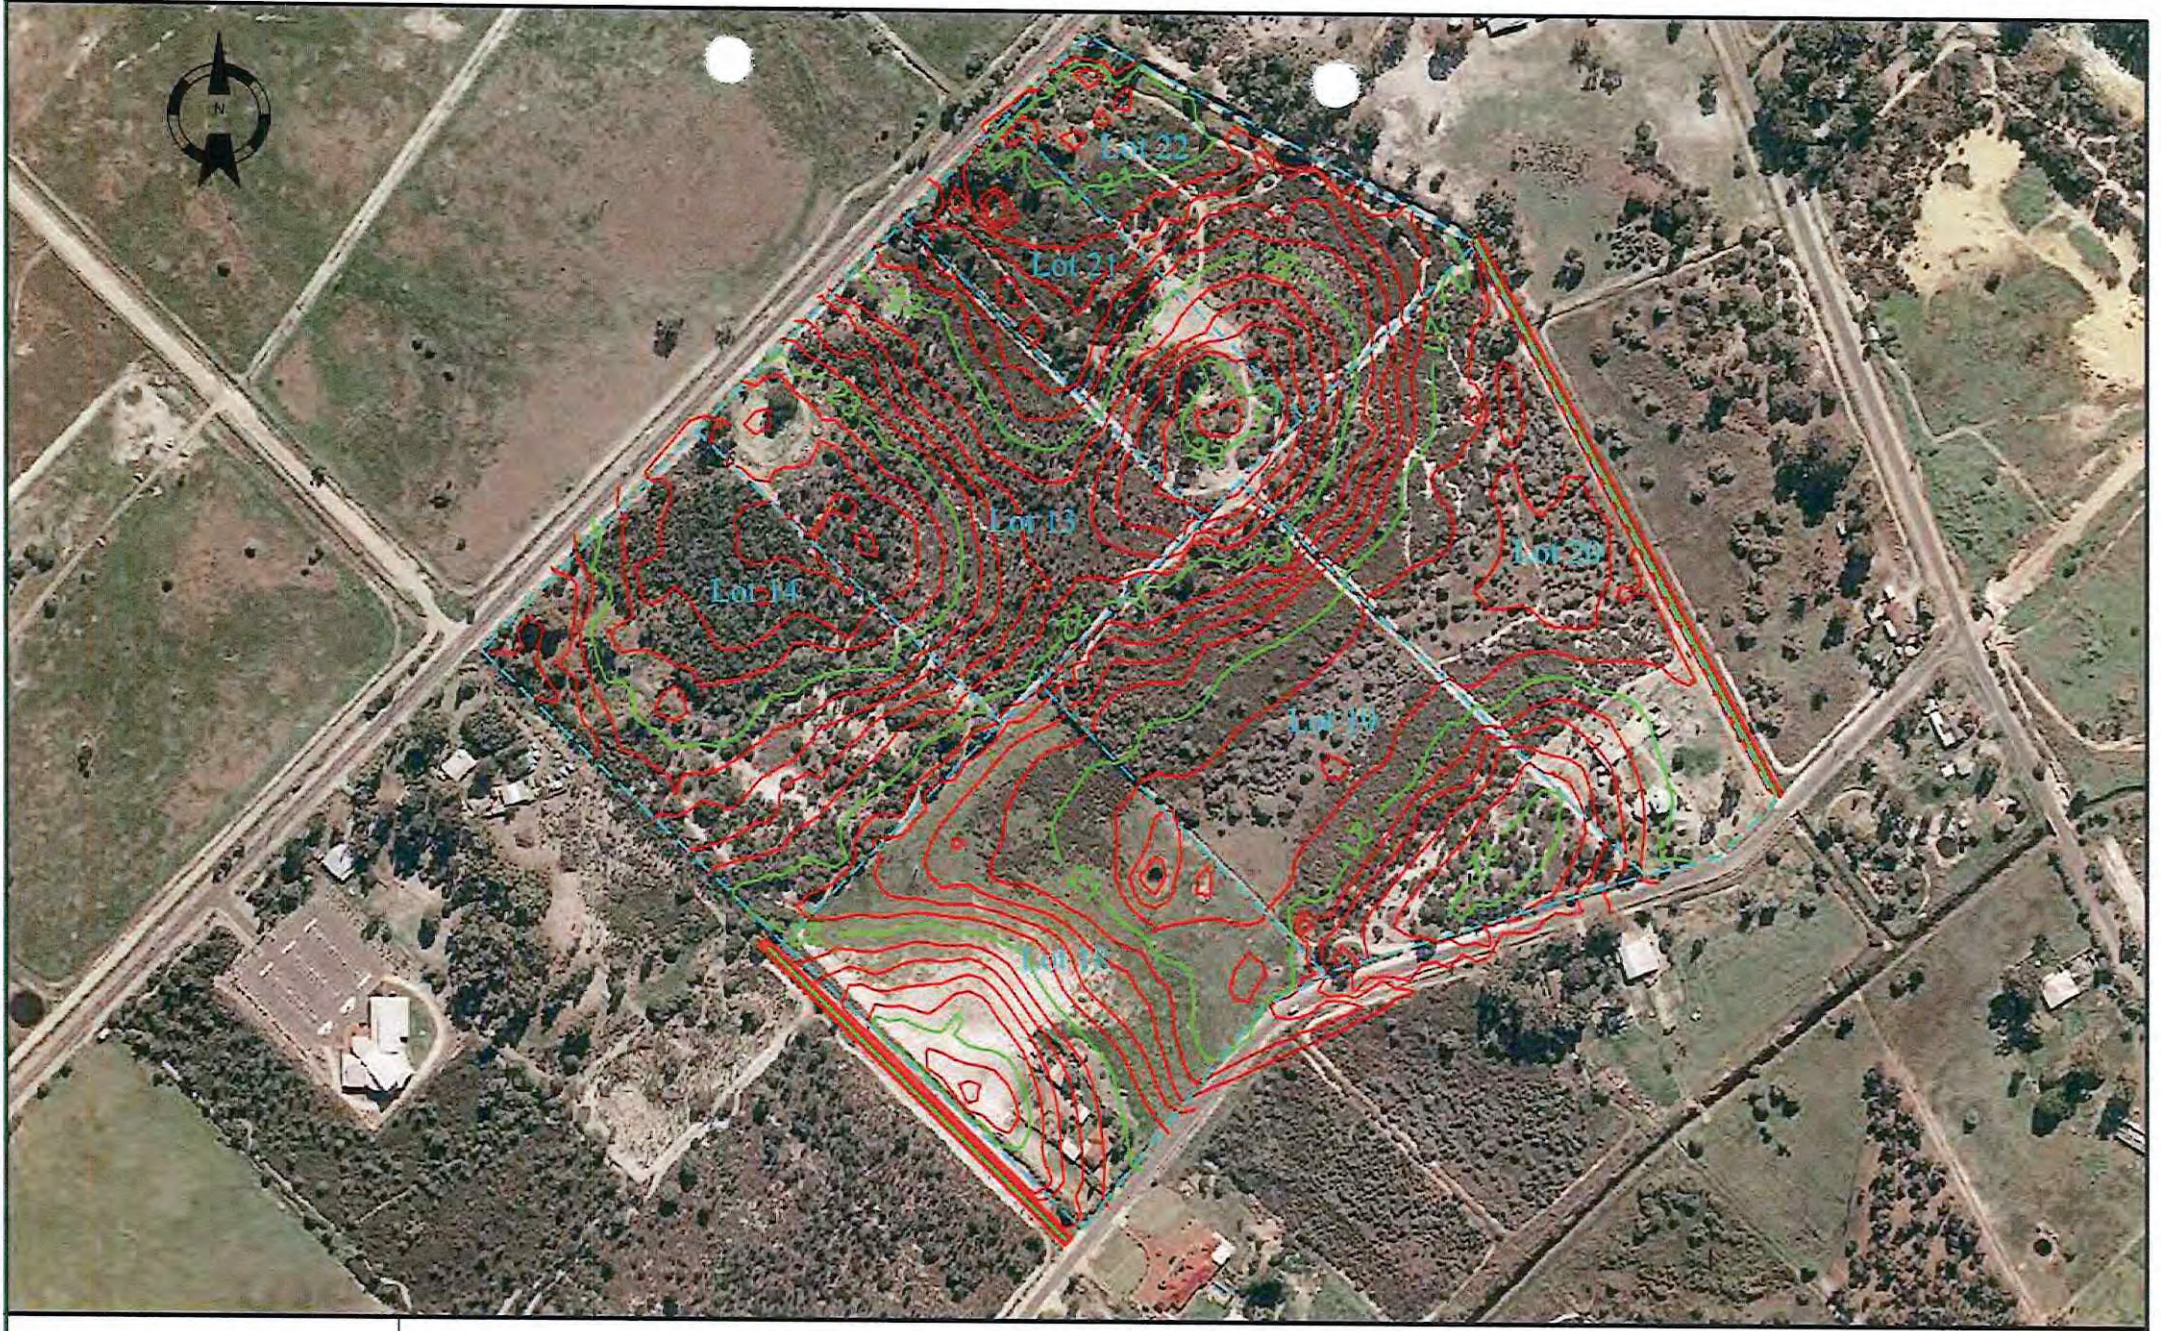
Figure 3 – Site Topography (mAHD)

Generally the area has a low relief with minor variations in topography. The site has a gentle slope from the centre of lots 13 and 14 at approximately 23m AHD towards the northern areas of lots 22 and 21 in addition to the central areas of lots 18, 19, and 20 down to approximately 20m AHD (Figure 3).

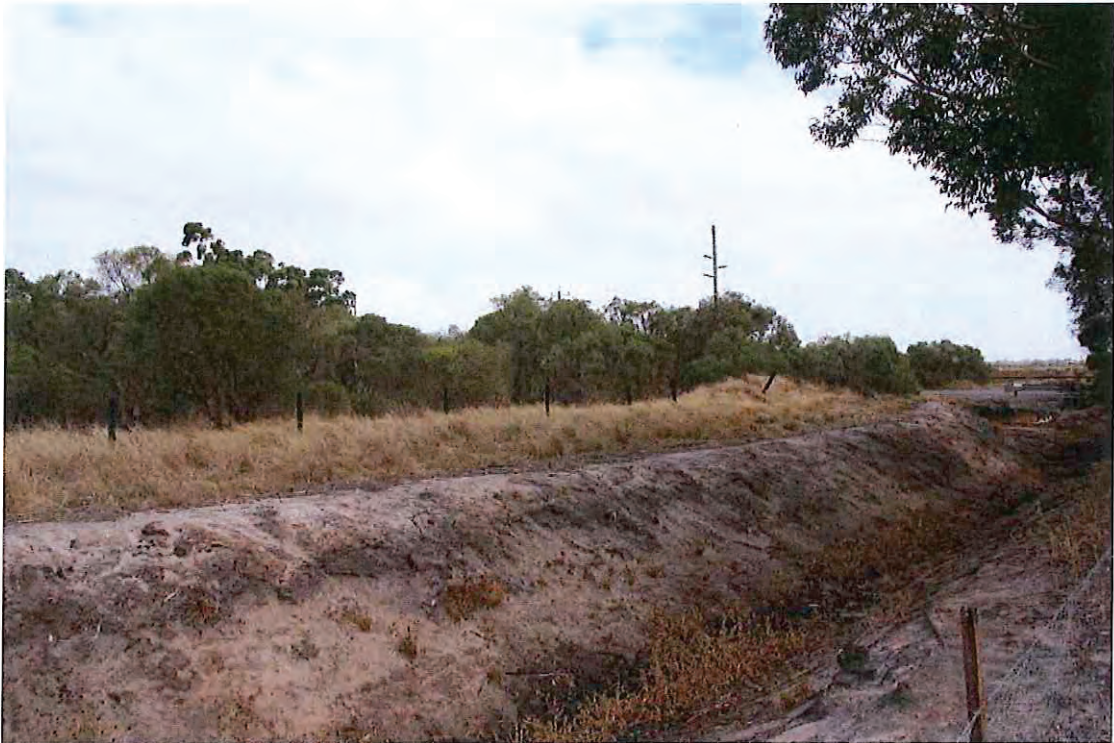
Photo 1 – Local Authority Drain (taken on the 21th May 2009)

The second drain invert located to the north east of lots 20 and 22 is approximately 0.9 m below AAMGL which is consistent with (JDA, 2002) findings of Local Authority drains within the area. Consequently, groundwater levels within 1km of this drain will decline logarithmically from between 0.57m to 0.08m, thus having a very significant impact on groundwater levels of the entire site (Photo 1).

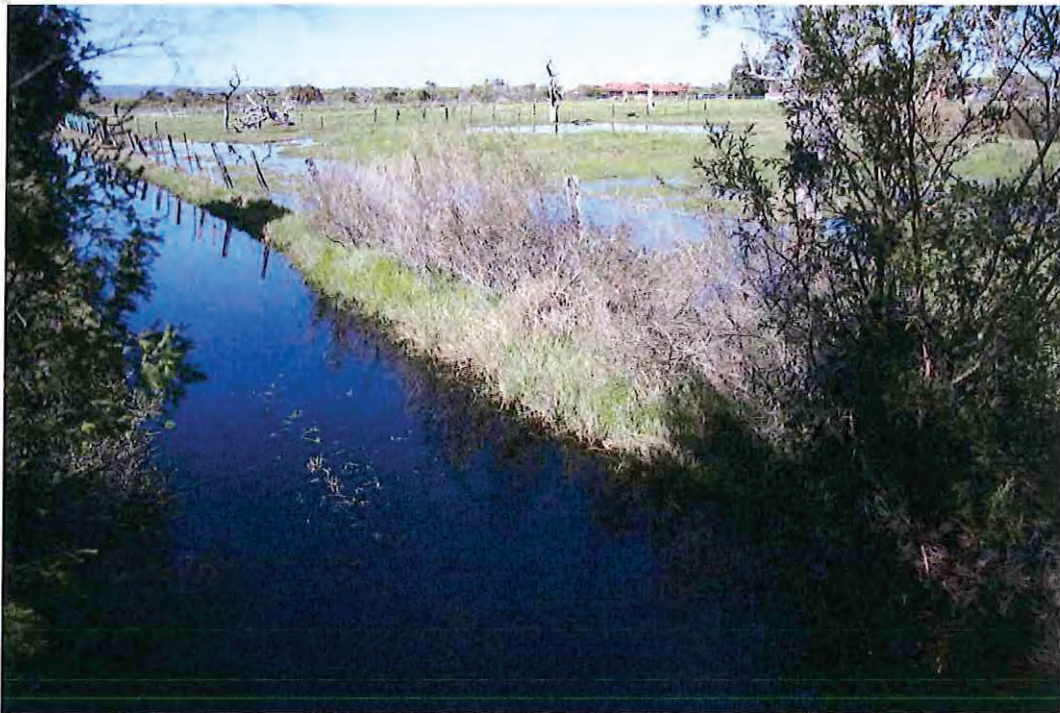
Photo 2 – Surface water on lots 18 and 19 (taken on the 4th September 2009).

According to the Southern River/ Forrestdale/ Brookdale/ Wungong Urban Water Management Strategy (2002) the site has no associated flood risk even in a 1 in 100 year ARI event. However, observation take during site visitors indicate that the areas of lots 18, 19 and to limited extent lot 20 (i.e areas are generally under 20.8m AHD) are prone to surface inundation in the winter months (Photo 2).

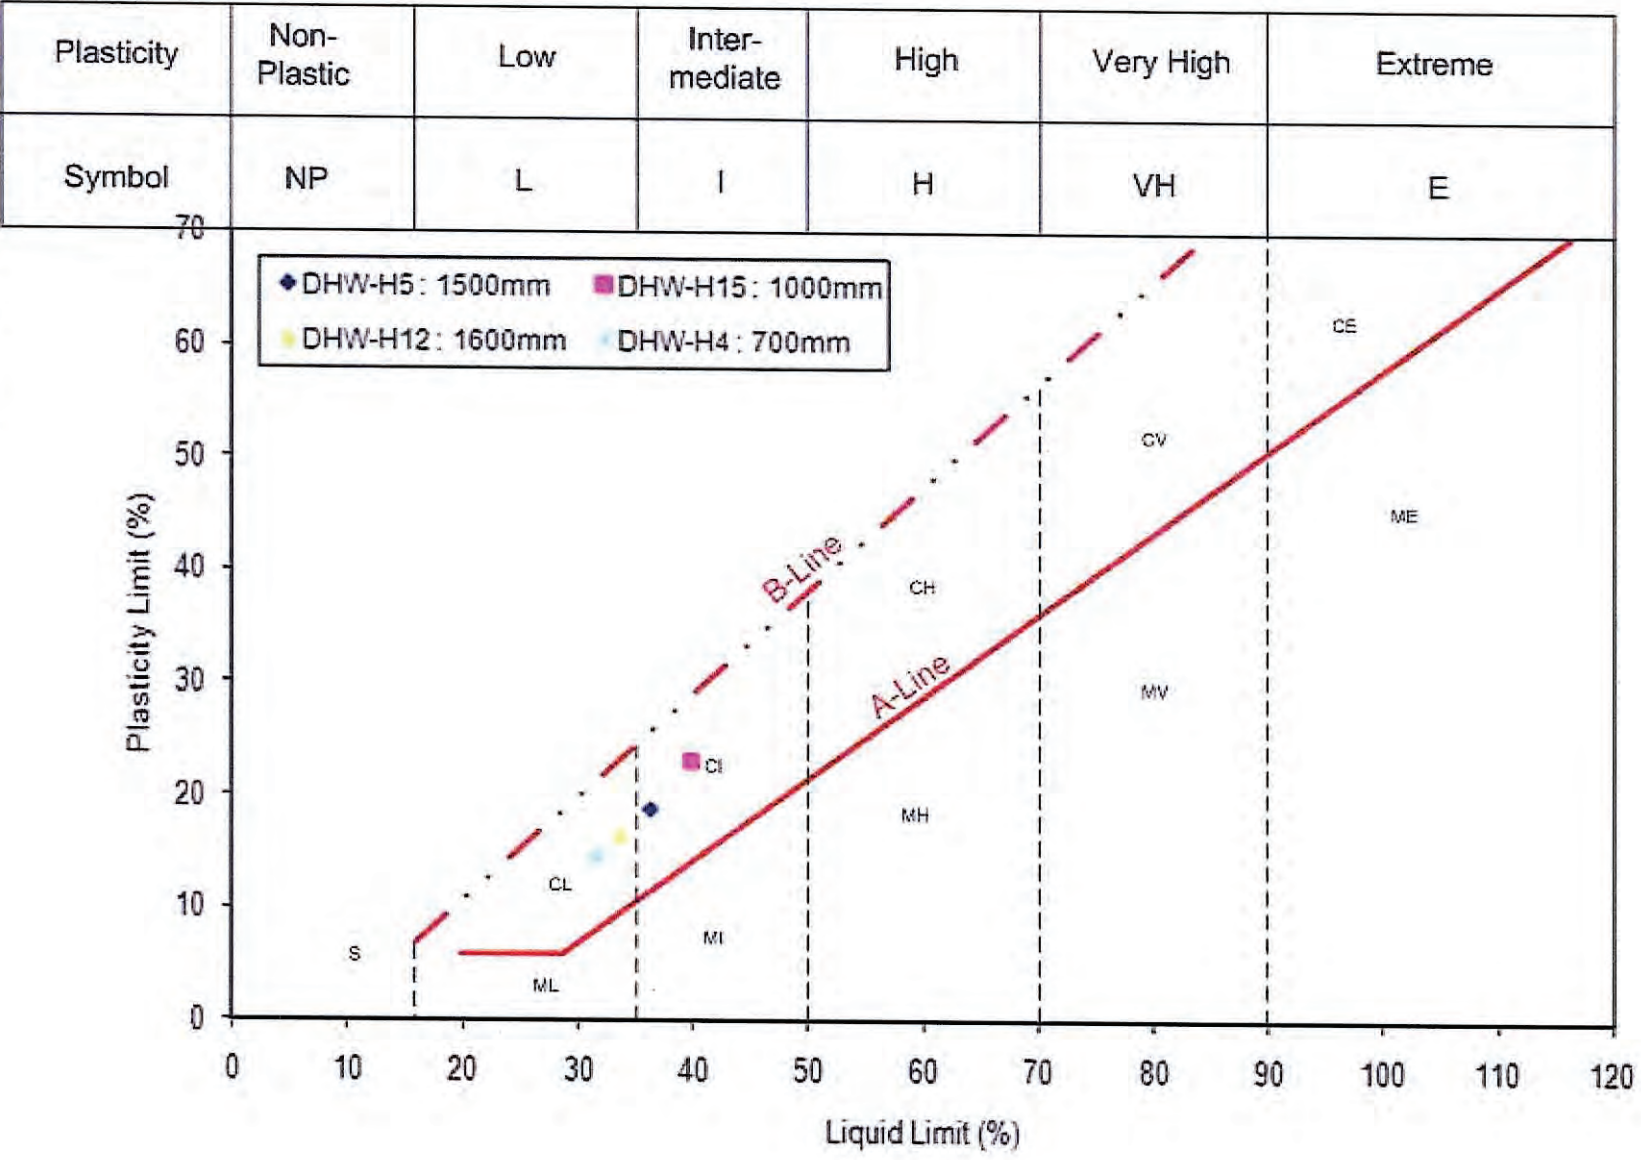
Figure 11 - Atterberg Limits Results

The Atterberg limits tests are simple standardized tests that were developed to determine the water contents that will induce particular behaviour, and provides a useful measure of potential soil reactivity and ground movements, which are fundamental in foundation design. Of the samples collected during the excavation of the 12 test pits, four samples of interest underwent Atterberg limits investigations.

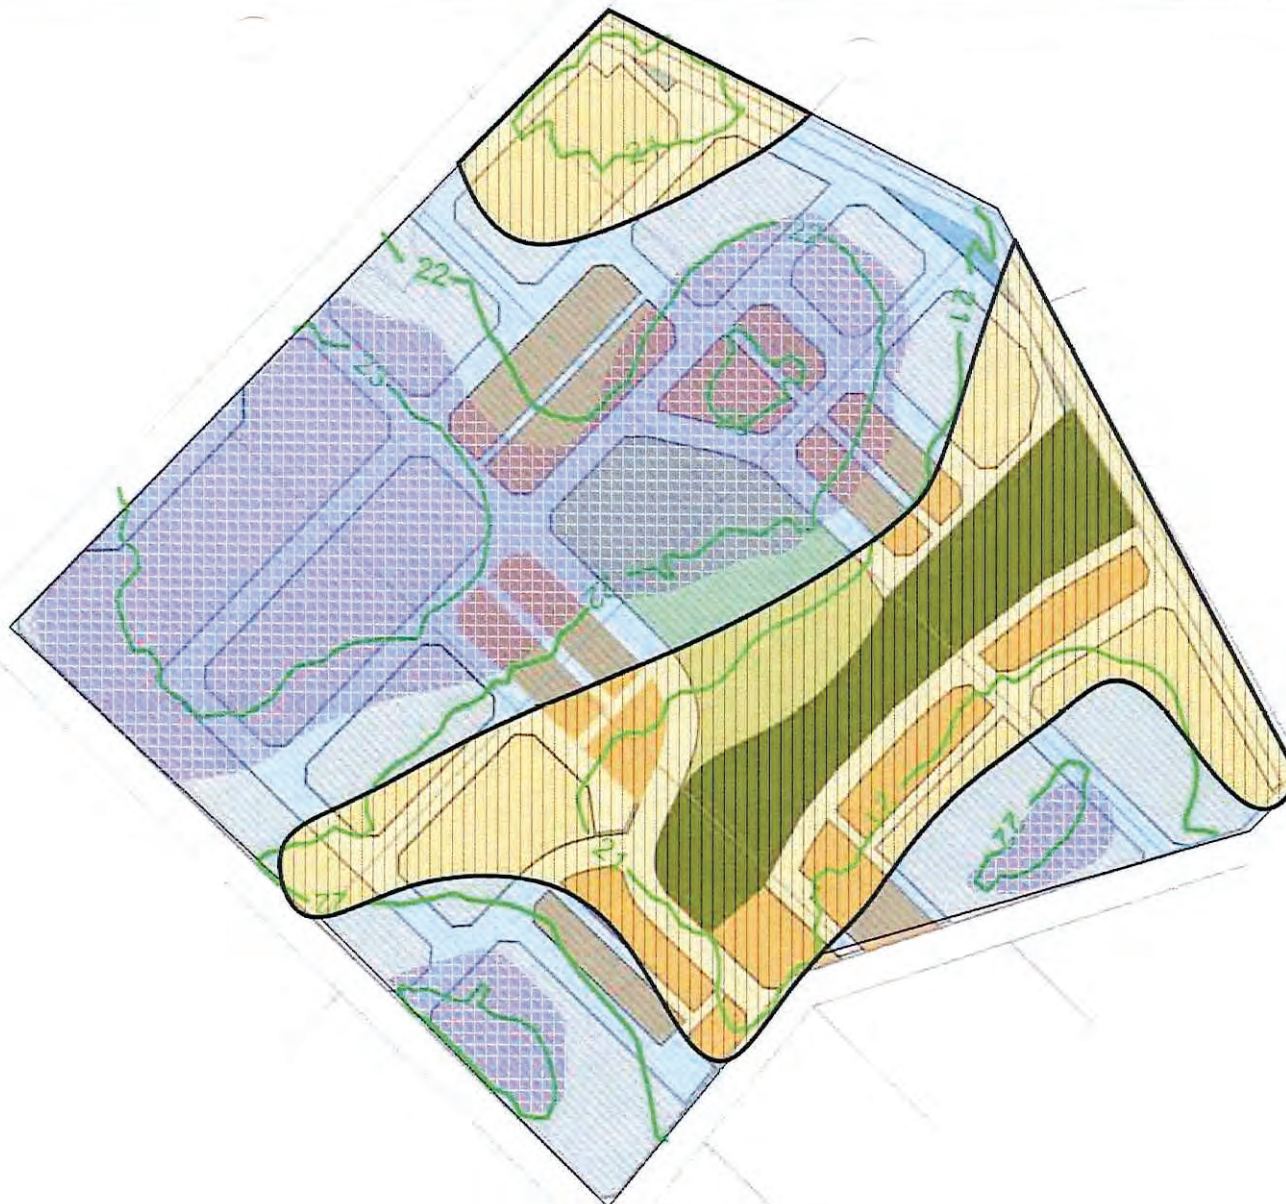
Figure 12 – Site Classification and Fill Excavation Areas.

The majority site is classified as “Class A” as defined in the Residential Slab and Footings (Australian Standard 2870), as the natural sand cover over the more reactive sandy loam layer is greater than 1.5m, thus little to no ground movement from moisture is expected. A proportion of the site which currently has less than 1.5m, but greater than 0.8m of natural sand cover over the more reactive sandy loam layer is classified as “Class S”, as it may be slightly reactive and thus result in slight movement from moisture changes (Figure 12). Notwithstanding, “Class S” areas can be upgraded to “Class A” via the application of engineered sandy fill, provided the sand cover over the sandy loam layer is greater than 1.5m thick. Such fill is available on site, in areas above 22.5m ADH (Figure 12).

Atterberg Limits analysis provides a useful measure of the potential soil reactivity and ground movements, which relate to shallow foundation design. Whereas the Pinjarra Plain formations are known to be generally reactive (they shrink in response to drying and swell under rewetting), without exception, all soils samples tested plot above the "A" line and have LL less than 50%, thus they are referred to as sandy loam with low or intermediate plasticity (Figure 12).

The majority of the site is classified as “Class A” as defined in the Residential Slab and Footings code AS2870 and suitable for building foundations. Areas classified as “Class S” require fill material to increase the depth of sand above a more reactive sandy loam layer to 1.5m in order for it to be upgraded to “Class A”. Survey and further geotechnical work may be required to confirm that site fill works have conformed to these recommendations.

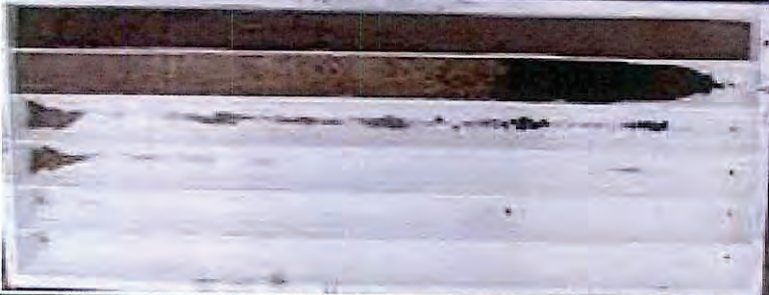
DHW5	No Photo Taken.	0	300	462	Grey, medium textured, Bassendean quarts sand, with organic material.
		300	700	484	Light grey, medium textured, Bassendean quarts sand.
		700	1500	422	Light brown, medium textured, Bassendean quarts sand over an impassable ferruginous induration "coffee rock".
DHW6

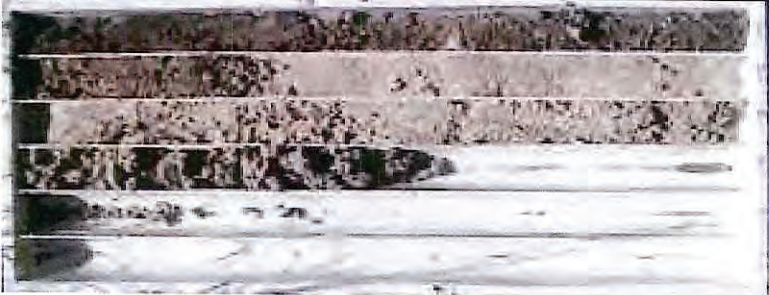
0	1000	328	Dark grey to grey, medium textured, Bassendean quarts sand, with organic material.
		1000	1600	424	Light brown to cream, medium to fine textured, Bassendean quarts sand.
		1600	1800	311	Brown, medium to fine textured, Bassendean quarts sand.
		1800	1900	306	Dark brown to black, medium to fine textured, Bassendean quarts sand over an impassable ferruginous induration "coffee rock".
DHW7

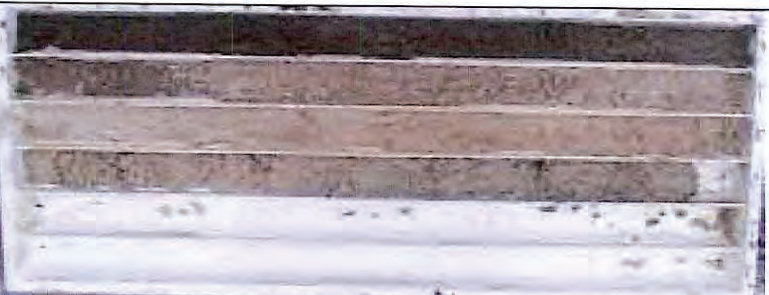
0	400	402	Dark grey to grey, medium textured, Bassendean quarts sand, with organic material.
		400	1200	421	Grey to light grey, medium textured, Bassendean quarts sand.
		1200	2800	385	White to cream, medium to fine textured, Bassendean quarts sand.

2800	3500	338	White to light grey, medium to fine textured, Bassendean quarts sand.
DHW8

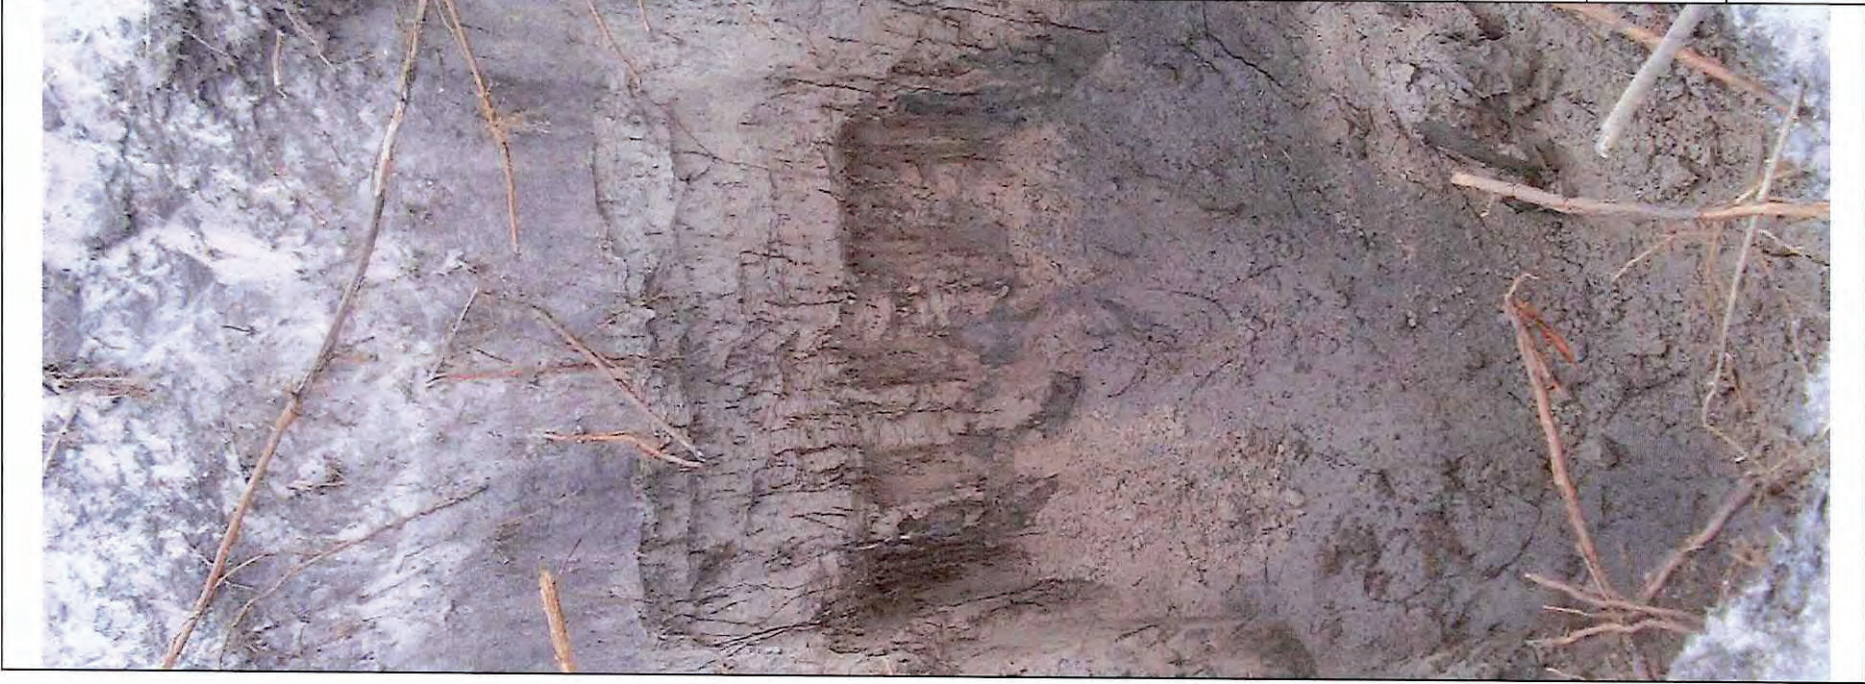
Depth (mm)		Type	Colour	Grade	Shape	Condition	Consistency	Structure	Organic / Fill / Waste	Cobble (%)	Gravel (%)	Sand (%)	Silt/Clay (%)
To	From									>6.3mm	>2mm	<2mm	<0.075
0	200	Sand	Grey	Poor	Sub A	Dry	Non-cohesiv.	Layer	Organic mat.	0.00	0.79	95.35	3.86
200	1200	Sand	Light Grey	Poor	Sub A	Dry	Non-cohesiv.	Layer	-	0.00	0.00	98.59	1.41
1200	2200	Sand	White	Poor	Sub A	Moist	Non-cohesiv.	Layer	-	0.00	0.13	98.30	1.57
2200	3000	Sand	Brown	Poor	Sub A	Wet	Non-cohesiv.	Layer	-	0.00	0.37	97.01	2.62

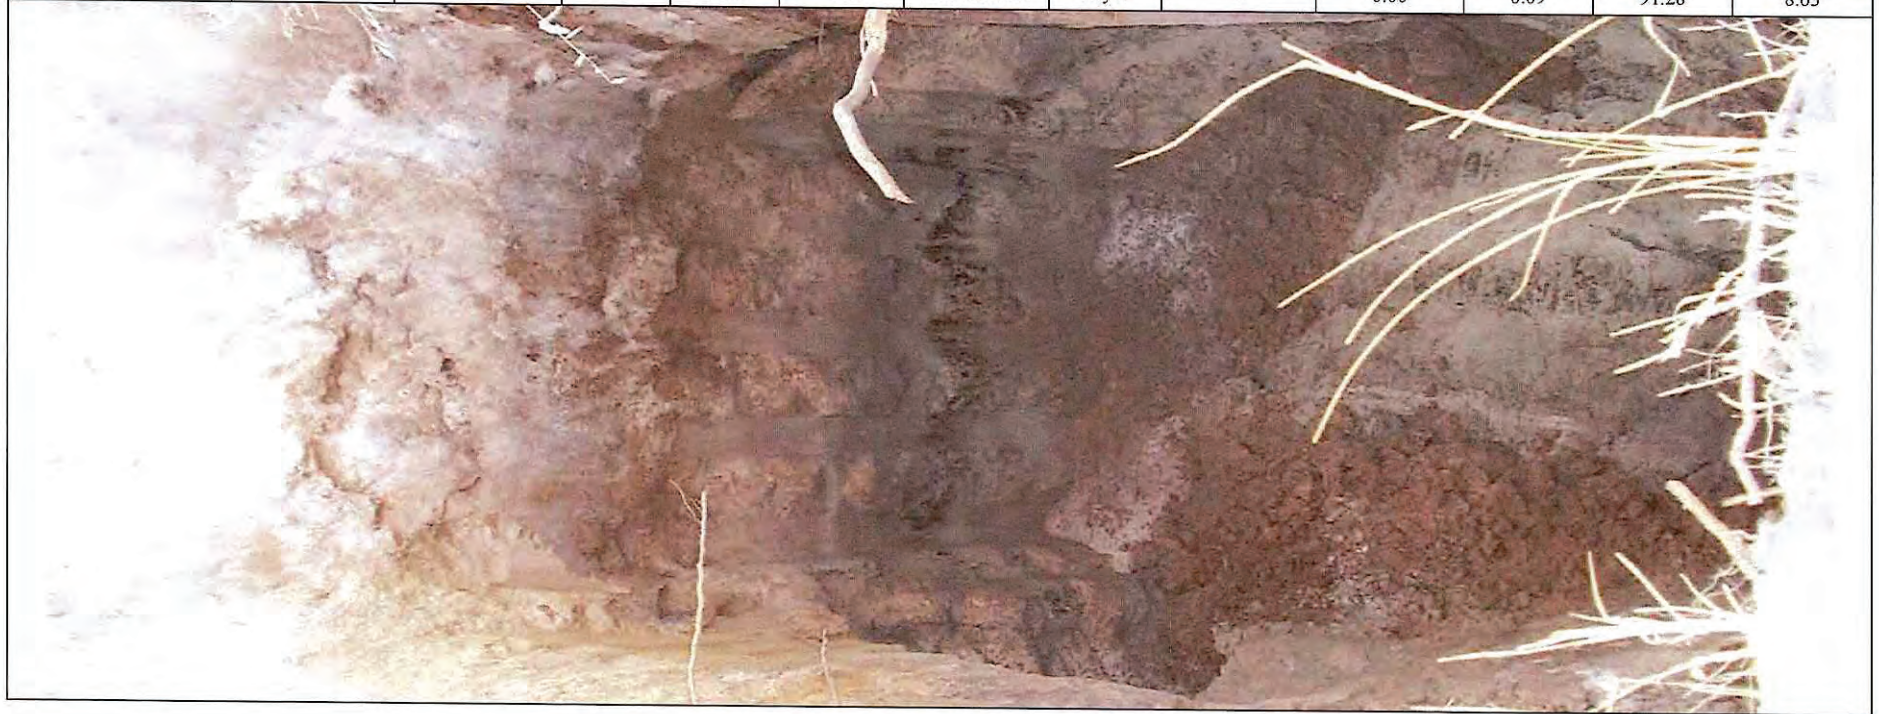
Investigator/s: ANJ
 Client: Urban Plan
 Location: Sub-Precinct 3E - Southern River
 Site No: DHW-H2

Depth (mm)		Type	Colour	Grade	Shape	Condition	Consistency	Structure	Organic / Fill / Waste	Cobble (%)	Gravel (%)	Sand (%)	Silt/Clay (%)
To	From									>6.3mm	>2mm	<2mm	<0.075
0	200	Sand	Light Grey	Poor	Sub A	Dry	Non-cohesiv.	Layer	Organic mat.	0.00	0.30	95.34	4.36
200	400	Sand	White	Poor	Sub A	Dry	Non-cohesiv.	Layer	-	0.00	0.64	96.26	3.10
400	1600	Sand	Red/Brown	Poor	Sub A	Moist	Non-cohesiv.	Layer	-	0.00	0.00	96.95	3.05
1600	2000	Sand	Grey/Brown	Poor	Sub A	Moist	Non-cohesiv.	Layer	-	0.00	0.82	92.67	6.51
2000	3000	Sand	Grey	Poor	Sub A	Wet	Non-cohesiv.	Layer	-	0.00	0.09	91.28	8.63

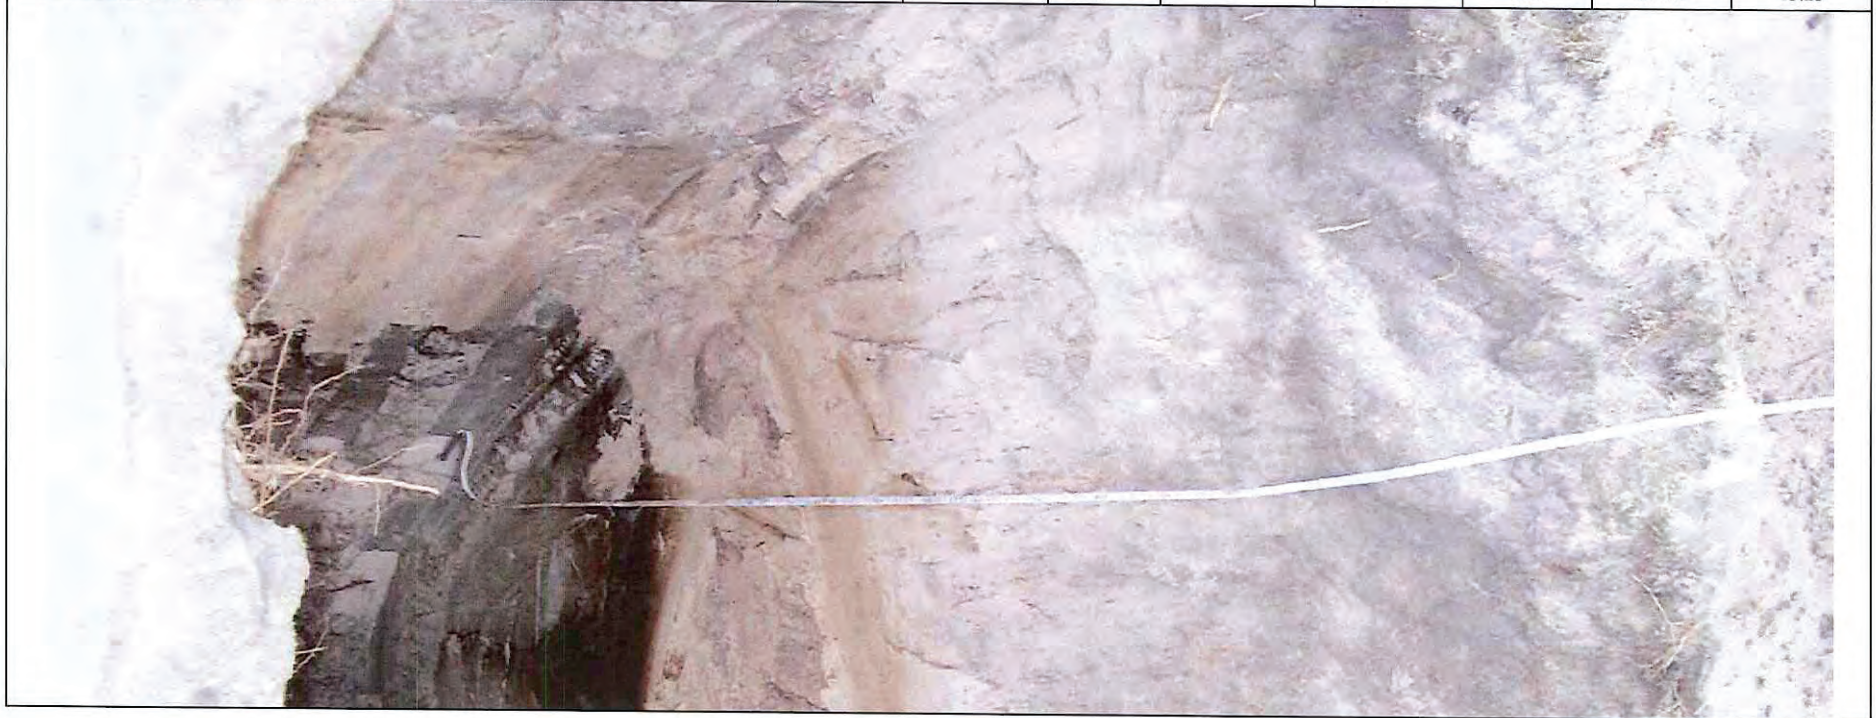
Investigator/s: ANJ
 Client: Urban Plan
 Location: Sub-Precinct 3E - Southern River
 Site No: DHW-H3

Depth (mm)		Type	Colour	Grade	Shape	Condition	Consistency	Structure	Organic / Fill / Waste	Cobble (%)	Gravel (%)	Sand (%)	Silt/Clay (%)
To	From									>6.3mm	>2mm	<2mm	<0.075
0	300	Sand	Grey	Poor	Sub A	Dry	Non-cohesiv.	Layer	Organic mat.	0.00	1.05	95.25	3.70
300	1500	Sand	Grey to White	Poor	Sub A	Dry	Non-cohesiv.	Layer	-	0.00	0.74	95.70	3.56
1500	1800	Rock	Black to Brown	-	-	Moist	Stiff	Layer	-	-	-	-	-
1800	3000	Loamy Sand	Grey to Green	Poor	Sub A	Wet	Soft	Layer	-	0.00	0.09	86.66	13.25

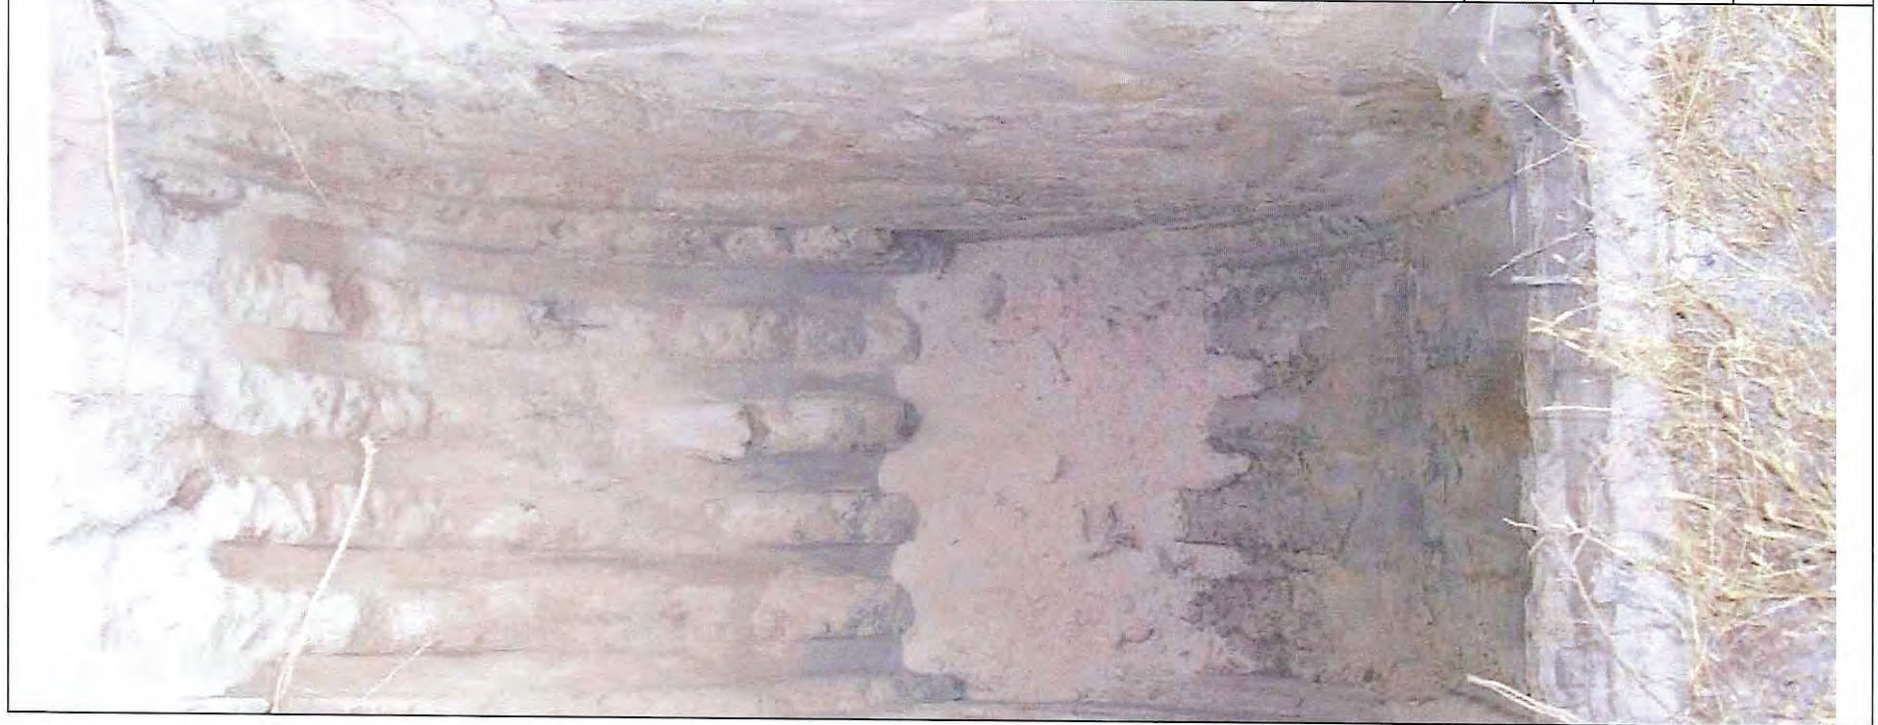
Investigator/s: ANJ
 Client: Urban Plan
 Location: Sub-Precinct 3E - Southern River
 Site No: DHW-H4

Depth (mm)		Type	Colour	Grade	Shape	Condition	Consistency	Structure	Organic / Fill / Waste	Cobble (%)	Gravel (%)	Sand (%)	Silt/Clay (%)
To	From									>6.3mm	>2mm	<2mm	<0.075
0	30	Sand	White	Poor	Sub A	Dry	Non-cohesiv.	Layer	Organic mat.	0.00	0.79	95.35	3.86
30	700	Sand	Cream to White	Poor	Sub A	Dry	Non-cohesiv.	Layer	-	0.00	0.82	91.52	7.66
700	2000	Loamy Sand	Yellow to White	Poor	Sub A	Moist	Soft	Layer	-	0.00	0.00	86.18	13.82
2000	3000	Sandy Loam	Grey to Green	Poor	Sub A	Wet	Soft	Layer	-	0.00	0.06	77.82	22.12

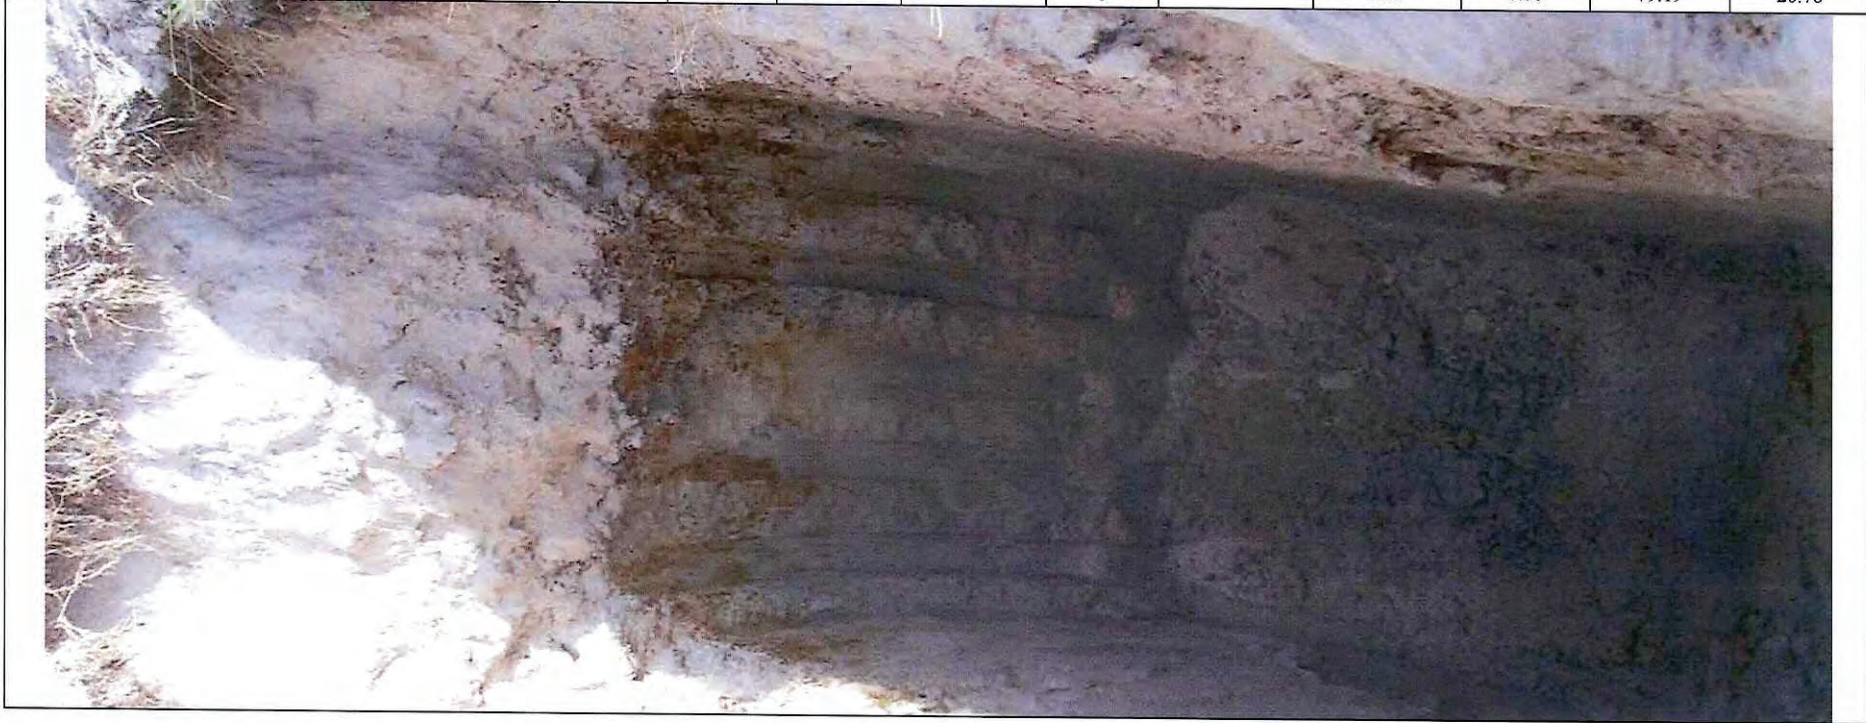
Investigator/s: ANJ
 Client: Urban Plan
 Location: Sub-Precinct 3E - Southern River
 Site No: DHW-H5

Depth (mm)		Type	Colour	Grade	Shape	Condition	Consistency	Structure	Organic / Fill / Waste	Cobble (%)	Gravel (%)	Sand (%)	Silt/Clay (%)
To	From									>6.3mm	>2mm	<2mm	<0.075
0	200	Sand	Grey	Poor	Sub A	Dry	Non-cohesiv.	Layer	Organic mat.	0.00	0.09	96.96	2.95
200	1000	Sand	White to Orange	Poor	Sub A	Dry	Non-cohesiv.	Layer	-	0.00	0.35	97.16	2.49
1000	1500	Gravel Loamy Sand	Orange	Poor	Sub A	Moist	Non-cohesiv.	Layer	-	0.00	5.72	75.25	19.03
1500	3000	Sandy Loam	Grey to Green	Poor	Sub A	Wet	Soft	Layer	-	0.00	0.06	79.19	20.76

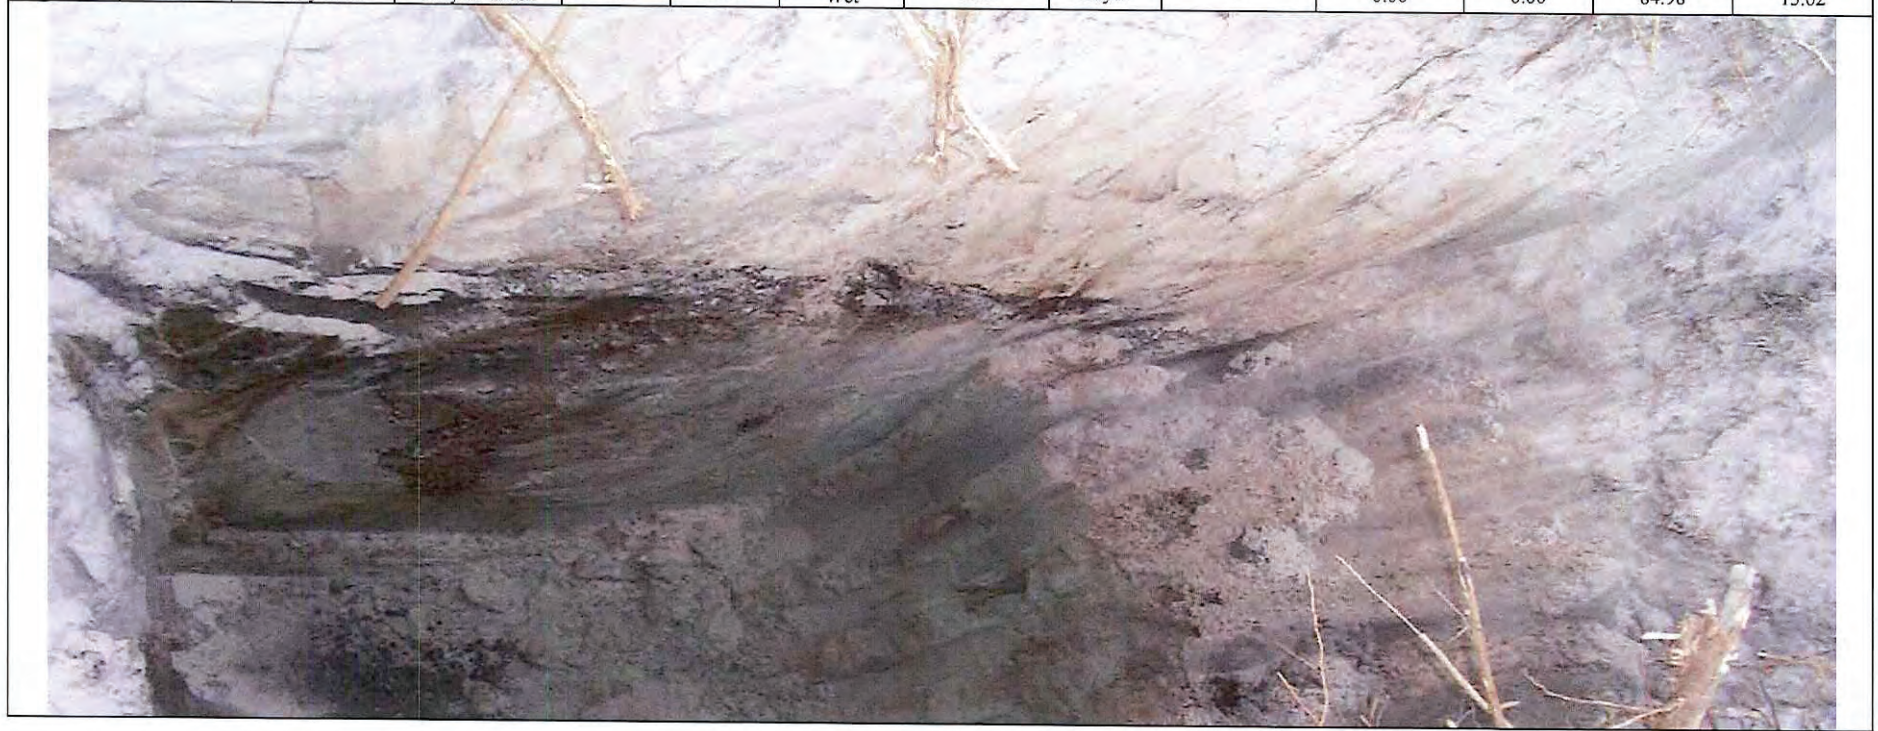
Investigator/s: ANJ
 Client: Urban Plan
 Location: Sub-Precinct 3E - Southern River
 Site No: DHW-H6

Depth (mm)		Type	Colour	Grade	Shape	Condition	Consistency	Structure	Organic / Fill / Waste	Cobble (%)	Gravel (%)	Sand (%)	Silt/Clay (%)
To	From									>6.3mm	>2mm	<2mm	<0.075
0	100	Sand	Grey	Poor	Sub A	Dry	Non-cohesiv.	Layer	Organic mat.	0.00	0.77	96.69	2.54
100	1400	Sand	Grey to White	Poor	Sub A	Dry	Non-cohesiv.	Layer	-	0.00	0.00	99.30	1.30
1400	1600	Rock	Black to Brown	Poor	Sub A	Moist	Firm	Layer	-	-	-	-	-
1600	3000	Loamy Sand	Grey to Green	Poor	Sub A	Wet	Soft	Layer	-	0.00	0.00	84.98	15.02
