Appendix 1 – Bioscience Geotech Report

GEOTECHNICAL REPORT

**LOTS 13, 14, 21 & 22
SOUTHERN RIVER ROAD
AND
LOTS 18, 19 & 20
MATISON STREET
SOUTHERN RIVER
MARCH 2010**

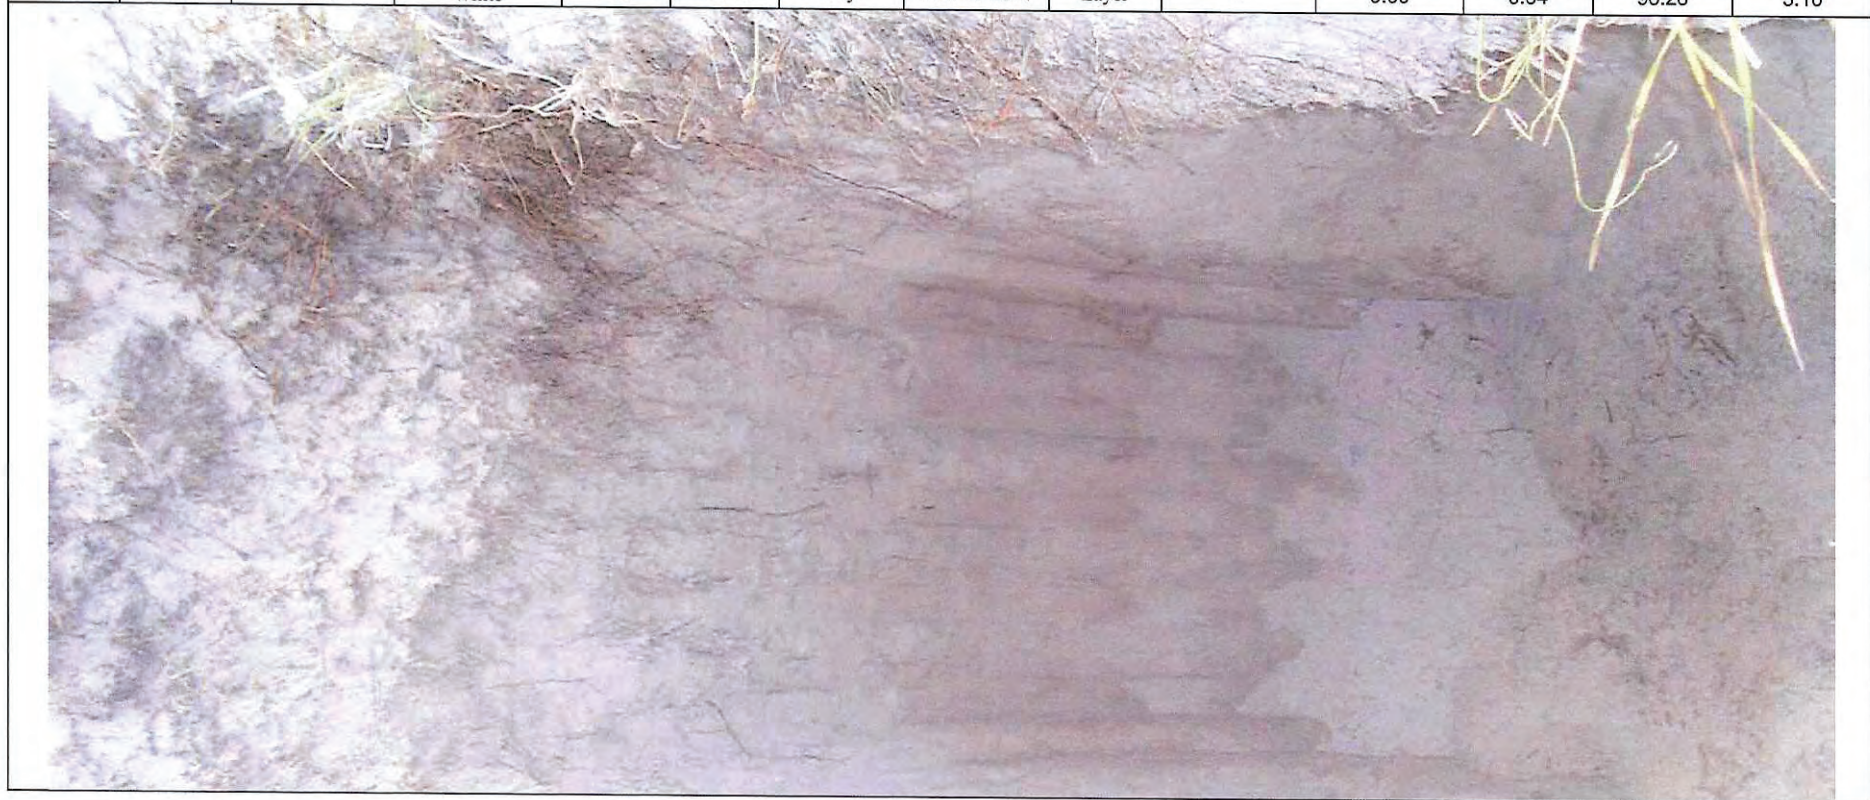
Investigator/s: ANJ
Client: Urban Plan
Location: Sub-Precinct 3E - Southern River
Site No: DHW-H7

Depth (mm)		Type	Colour	Grade	Shape	Condition	Consistency	Structure	Organic / Fill / Waste	Cobble (%)	Gravel (%)	Sand (%)	Silt/Clay (%)
To	From									>6.3mm	>2mm	<2mm	<0.075
0	300	Sand	Light Grey	Poor	Sub A	Dry	Non-cohesiv.	Layer	Organic mat.	0.00	0.12	98.34	1.53
300	3000	Sand	White	Poor	Sub A	Dry	Non-cohesiv.	Layer	-	0.00	0.64	96.26	3.10

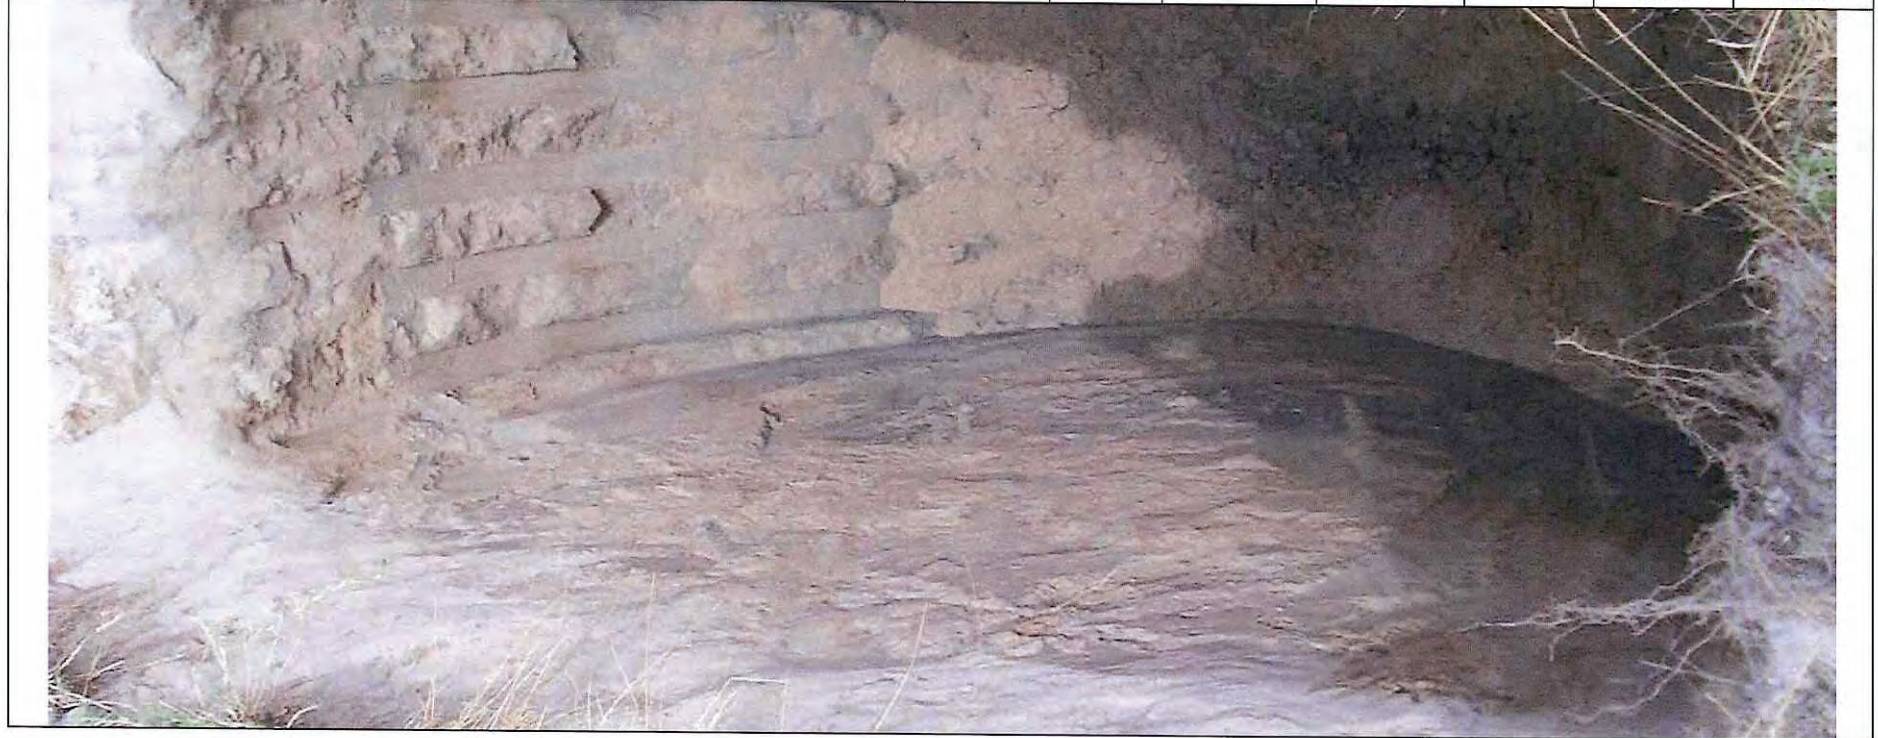
Depth (mm)		Type	Colour	Grade	Shape	Condition	Consistency	Structure	Organic / Fill / Waste	Cobble (%)	Gravel (%)	Sand (%)	Silt/Clay (%)
To	From									>6.3mm	>2mm	<2mm	<0.075
0	200	Sand	Grey	Poor	Sub A	Dry	Non-cohesiv.	Layer	Organic mat.	0.00	0.74	95.63	3.63
200	1100	Sand	White	Poor	Sub A	Dry	Non-cohesiv.	Layer	-	0.00	0.76	95.51	3.74
1100	2300	Loamy Sand	Grey	Poor	Sub A	Moist	Non-cohesiv.	Layer	-	0.00	0.82	87.90	11.28
2300	3000	Sandy Loam	Grey to Green	Poor	Sub A	Wet	Non-cohesiv.	Layer	-	0.00	0.06	76.53	23.41

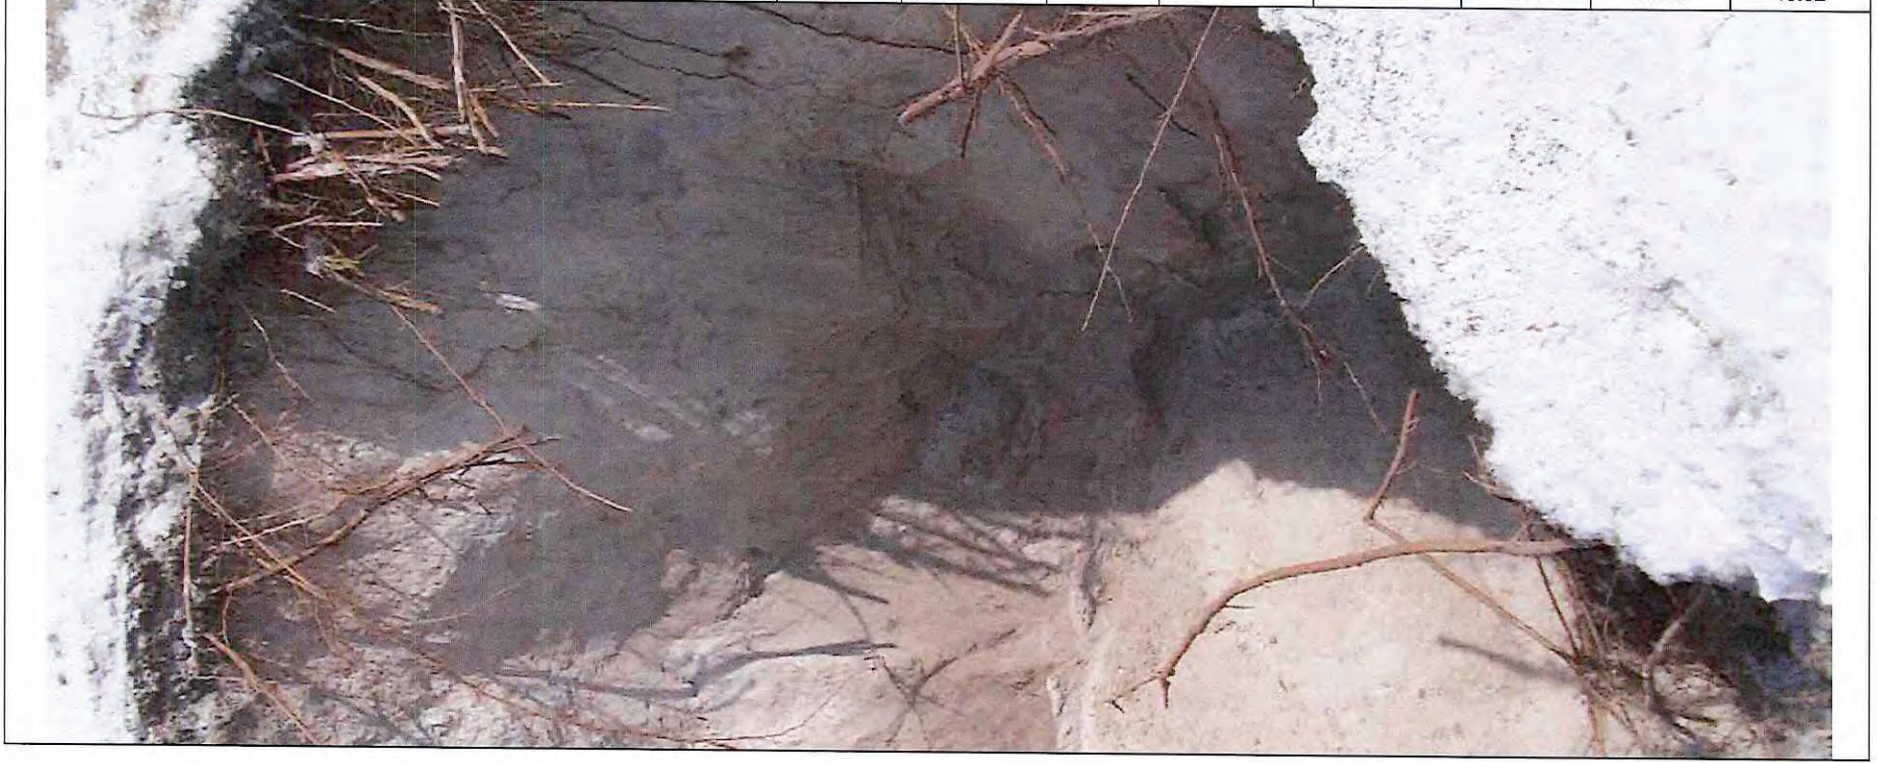
Investigator/s: ANJ
 Client: Urban Plan
 Location: Sub-Precinct 3E - Southern River
 Site No: DHW-H10

Depth (mm)		Type	Colour	Grade	Shape	Condition	Consistency	Structure	Organic / Fill / Waste	Cobble (%)	Gravel (%)	Sand (%)	Silt/Clay (%)
To	From									>6.3mm	>2mm	<2mm	<0.075
0	200	Sand	Grey	Poor	Sub A	Dry	Non-cohesiv.	Layer	Organic mat.	0.00	0.76	97.63	1.61
200	2100	Sand	White	Poor	Sub A	Dry	Non-cohesiv.	Layer	-	0.00	0.00	95.69	4.31
2100	3000	Loamy Sand	Grey to Brown	Poor	Sub A	Moist	Non-cohesiv.	Layer	-	0.00	0.00	84.98	15.02

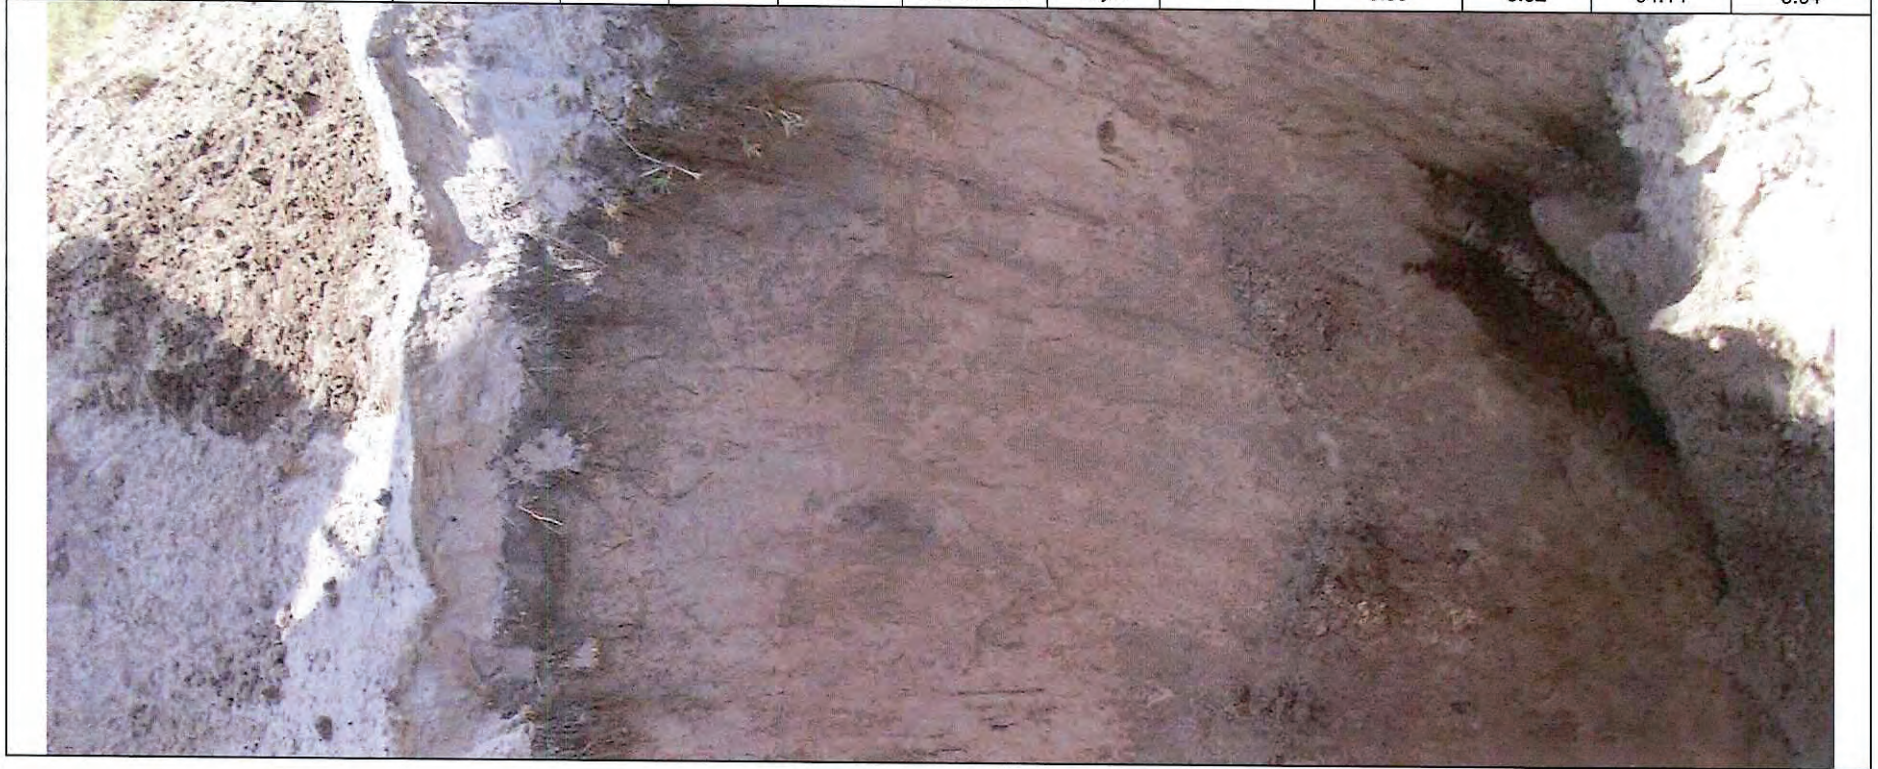
Investigator/s: ANJ
 Client: Urban Plan
 Location: Sub-Precinct 3E - Southern River
 Site No: DHW-H11

Depth (mm)		Type	Colour	Grade	Shape	Condition	Consistency	Structure	Organic / Fill / Waste	Cobble (%)	Gravel (%)	Sand (%)	Silt/Clay (%)
To	From									>6.3mm	>2mm	<2mm	<0.075
0	200	Sand	Grey	Poor	Sub A	Dry	Non-cohesiv.	Layer	Organic mat.	0.00	0.09	96.98	2.92
200	1700	Sand	White	Poor	Sub A	Dry	Non-cohesiv.	Layer	-	0.00	0.36	97.12	2.52
1700	3000	Sand	Brown	Poor	Sub A	Moist	Non-cohesiv.	Layer	-	0.00	0.82	94.14	5.04

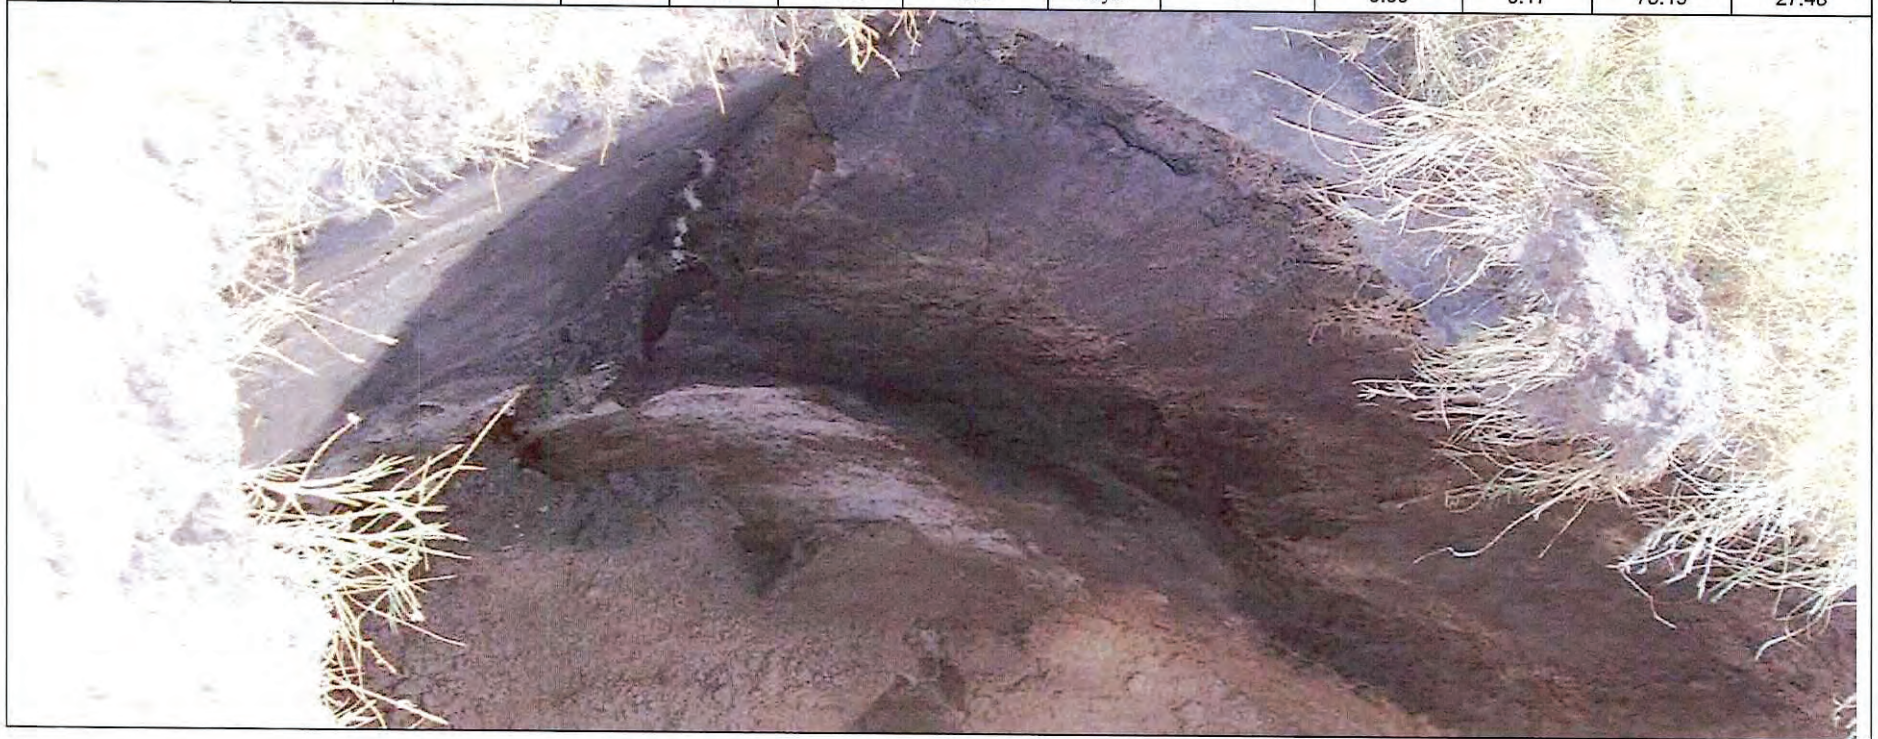
Investigator/s: ANJ
Client: Urban Plan
Location: Sub-Precinct 3E - Southern River
Site No: DHW-H12

Depth (mm)		Type	Colour	Grade	Shape	Condition	Consistency	Structure	Organic / Fill / Waste	Cobble (%)	Gravel (%)	Sand (%)	Silt/Clay (%)
To	From									>6.3mm	>2mm	<2mm	<0.075
0	400	Sand	Grey	Poor	Sub A	Dry	Non-cohesiv.	Layer	Organic mat.	0.00	0.00	96.43	3.57
400	1200	Sand	Light Grey	Poor	Sub A	Dry	Non-cohesiv.	Layer	-	0.00	0.95	94.41	4.64
1400	1600	Loamy Sand	Black	Poor	Sub A	Moist	Soft	Layer	-	0.00	0.00	87.84	12.16
1600	3000	Sandy Loam	Grey to Green	Poor	Sub A	Moist	Soft	Layer	-	0.00	0.17	73.19	27.48

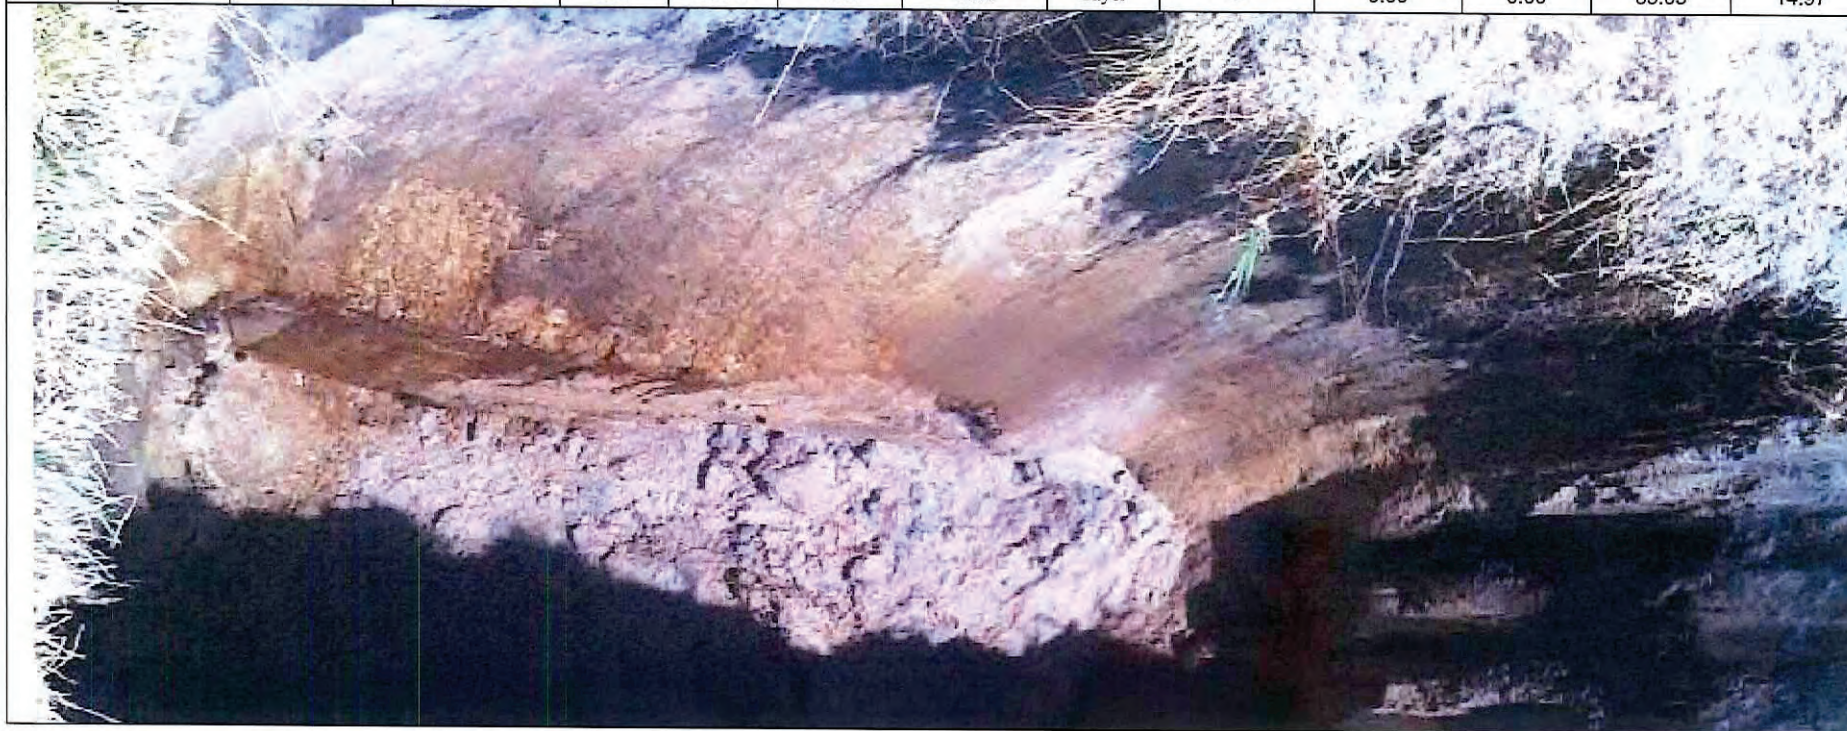
Investigator/s: ANJ
 Client: Urban Plan
 Location: Sub-Precinct 3E - Southern River
 Site No: DHW-H13

Depth (mm)		Type	Colour	Grade	Shape	Condition	Consistency	Structure	Organic / Fill / Waste	Cobble (%)	Gravel (%)	Sand (%)	Silt/Clay (%)
To	From									>6.3mm	>2mm	<2mm	<0.075
0	200	Sand	Grey	Poor	Sub A	Dry	Non-cohesiv.	Layer	Organic mat.	0.00	0.30	95.34	4.36
200	1100	Sand	Light Grey	Poor	Sub A	Dry	Non-cohesiv.	Layer	-	0.00	0.76	95.51	3.74
1100	2000	Loamy Sand	Brown	Poor	Sub A	Moist	Soft	Layer	-	0.00	0.00	87.84	12.16
2000	3000	Loamy Sand	Grey to Green	Poor	Sub A	Wet	Soft	Layer	-	0.00	0.00	85.03	14.97

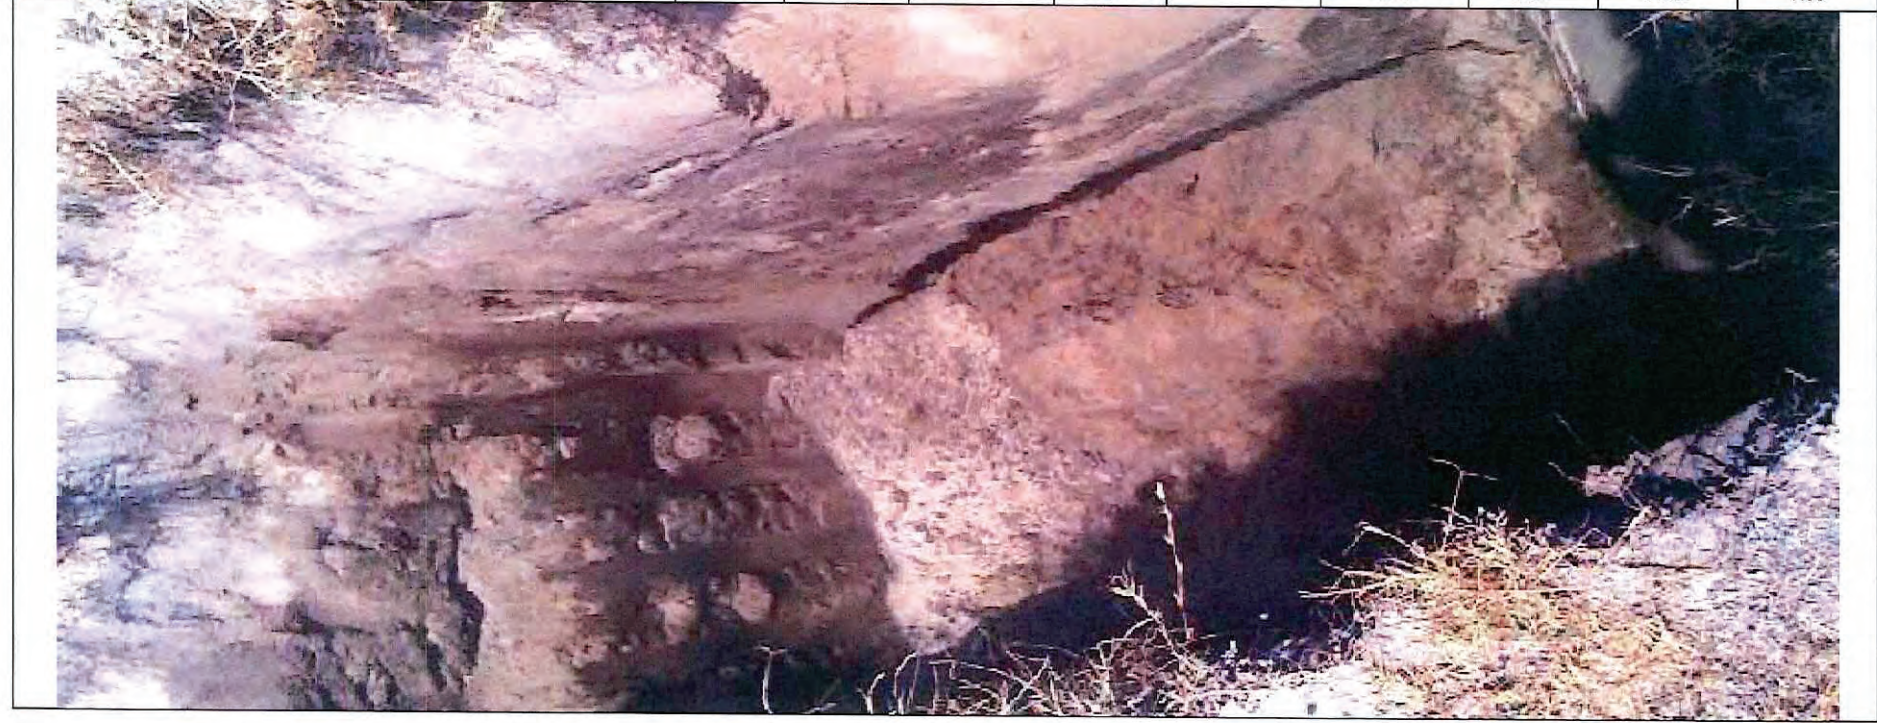
Investigator/s: ANJ
Client: Urban Plan
Location: Sub-Precinct 3E - Southern River
Site No: DHW-H14
Date: 11/02/2010
Photo No:
Eastings/Long: 6447464
Northings/Lat: 402512
Notes:

Depth (mm)		Type	Colour	Grade	Shape	Condition	Consistency	Structure	Organic / Fill / Waste	Cobble (%)	Gravel (%)	Sand (%)	Silt/Clay (%)
To	From									>6.3mm	>2mm	<2mm	<0.075
0	200	Sand	Grey	Poor	Sub A	Dry	Non-cohesiv.	Layer	Organic mat.	0.00	0.30	95.34	4.36
200	1400	Sand	Light Grey to White	Poor	Sub A	Dry	Non-cohesiv.	Layer	-	0.00	0.09	96.98	2.92
1400	1600	Loamy Sand	Brown	Poor	Sub A	Moist	Non-cohesiv.	Layer	-	0.00	0.09	89.22	10.68
1600	3000	Sand	Grey/Green	Poor	Sub A	Wet	Non-cohesiv.	Layer	-	0.00	0.82	91.52	7.66

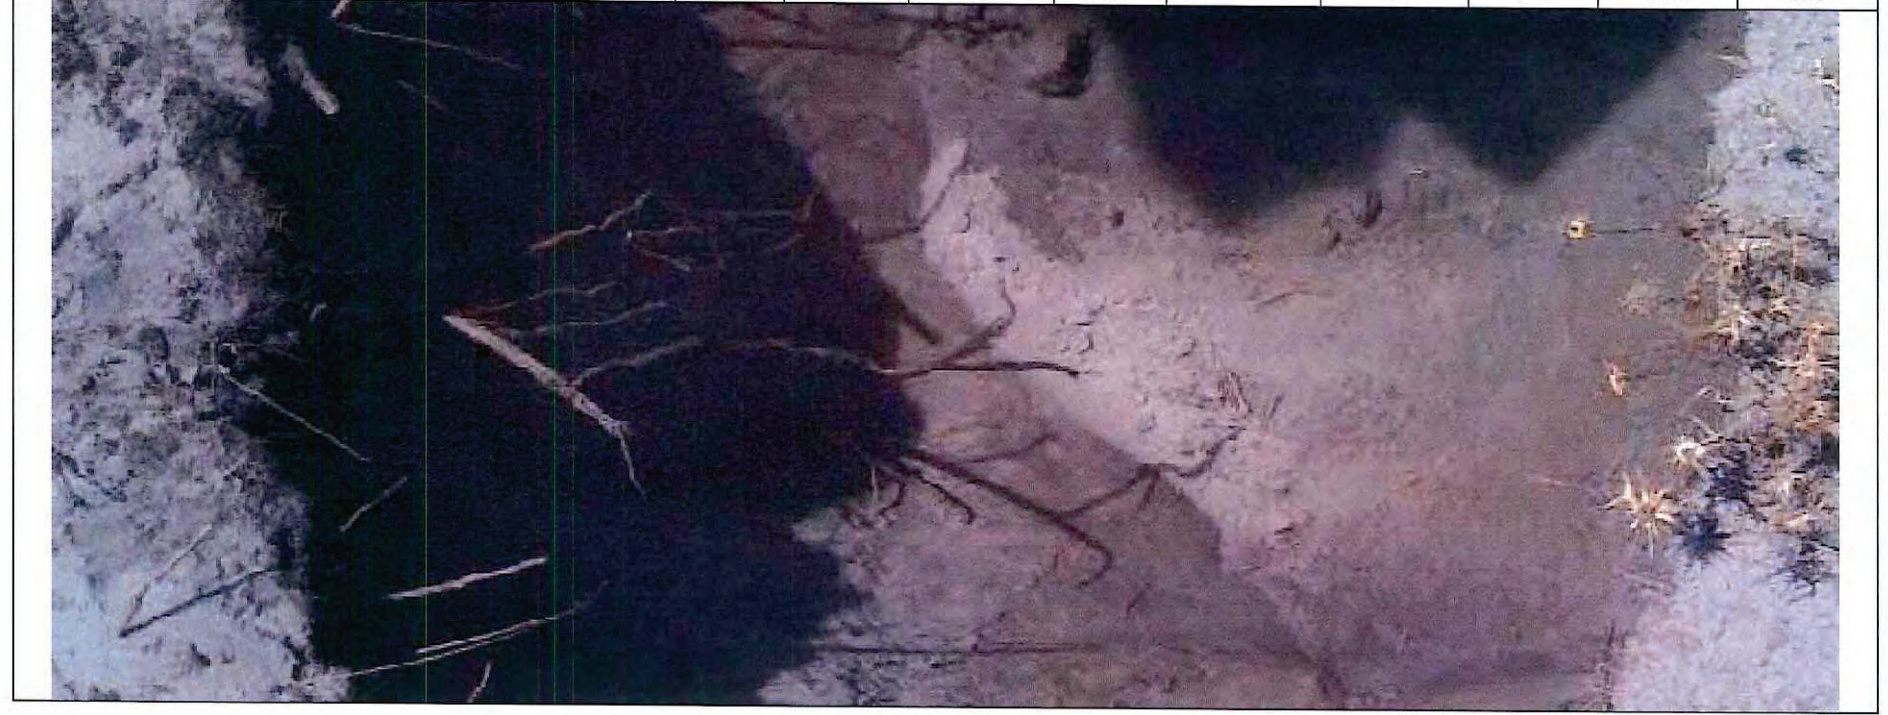
Investigator/s: ANJ
Client: Urban Plan
Location: Sub-Precinct 3E - Southern River
Site No: DHW-H15

Depth (mm)		Type	Colour	Grade	Shape	Condition	Consistency	Structure	Organic / Fill / Waste	Cobble (%)	Gravel (%)	Sand (%)	Silt/Clay (%)
To	From									>6.3mm	>2mm	<2mm	<0.075
0	200	Sand	Grey	Poor	Sub A	Dry	Non-cohesiv.	Layer	Organic mat.	0.00	0.28	95.59	4.12
200	2500	Sand	Grey to White	Poor	Sub A	Dry	Non-cohesiv.	Layer	-	0.00	1.30	96.67	2.18
350	3000	Sand	Brown	Poor	Sub A	Moist	Non-cohesiv.	Layer	-	0.00	0.75	97.07	2.18
